River Restoration 2023 Final Report  
December 2023

## **Introduction**

### **Drain Lake Brook**

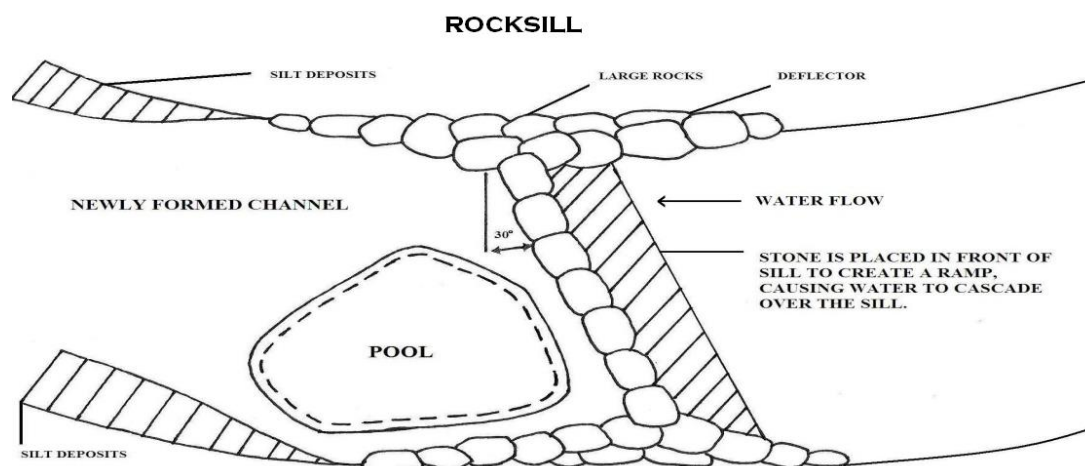
General rock sill specification

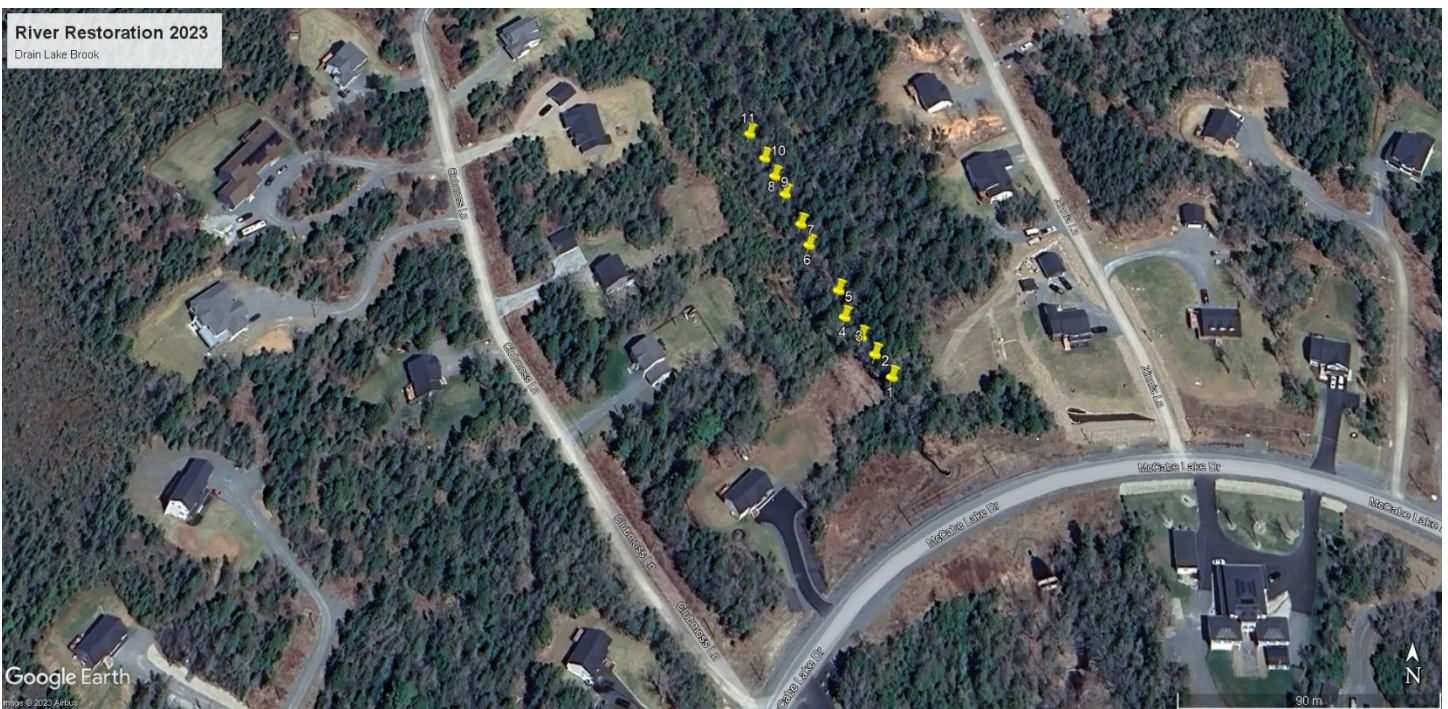
River Restoration 2023 – Drain Lake Brook habitat restoration installations (sites 1 through 11 – one rock sill and one deflector installation at each site).

22 Structures in total were installed in Drain Lake Brook (11 rock sills and 11 deflectors) at 11 sites as part of our River Restoration 2023 project. This work in a reach of approximately 145m, where further work was completed (such as pool enhancement, thalweg definition, etc.) of brook restored approximately 320m<sup>2</sup> of fish habitat.

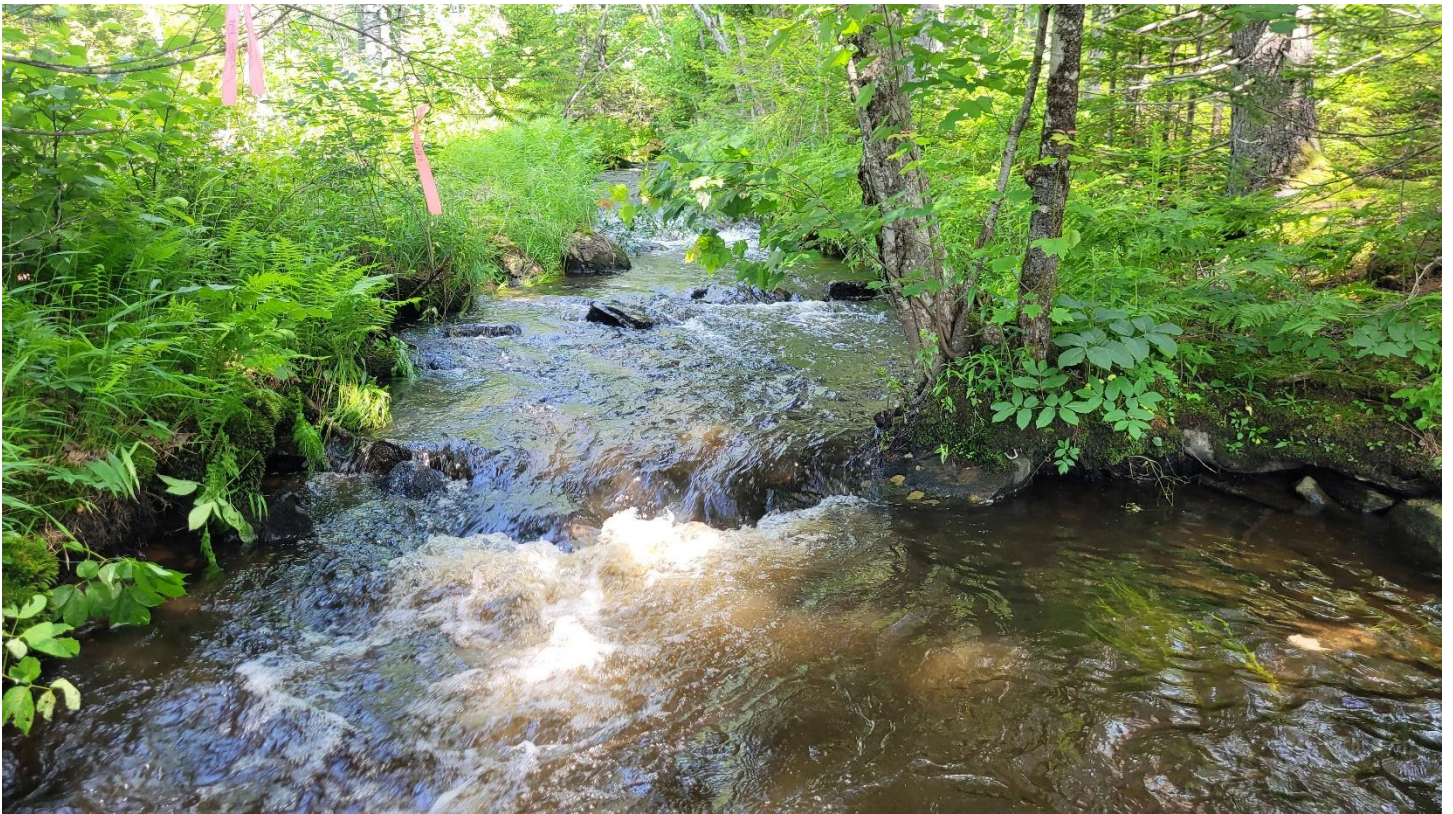
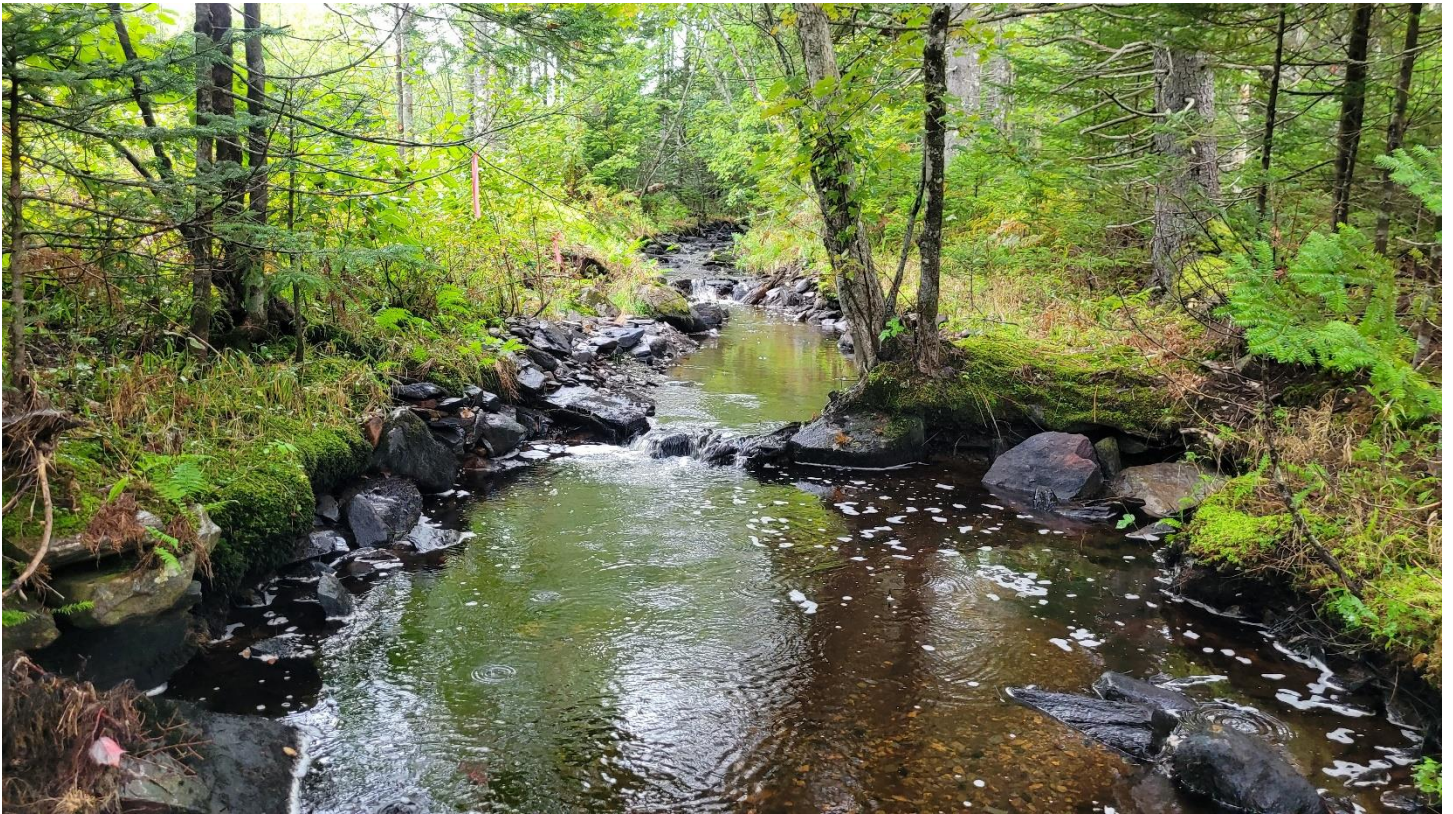
Site 1 – Rock sill 1 with deflector - before (above) and after (below)

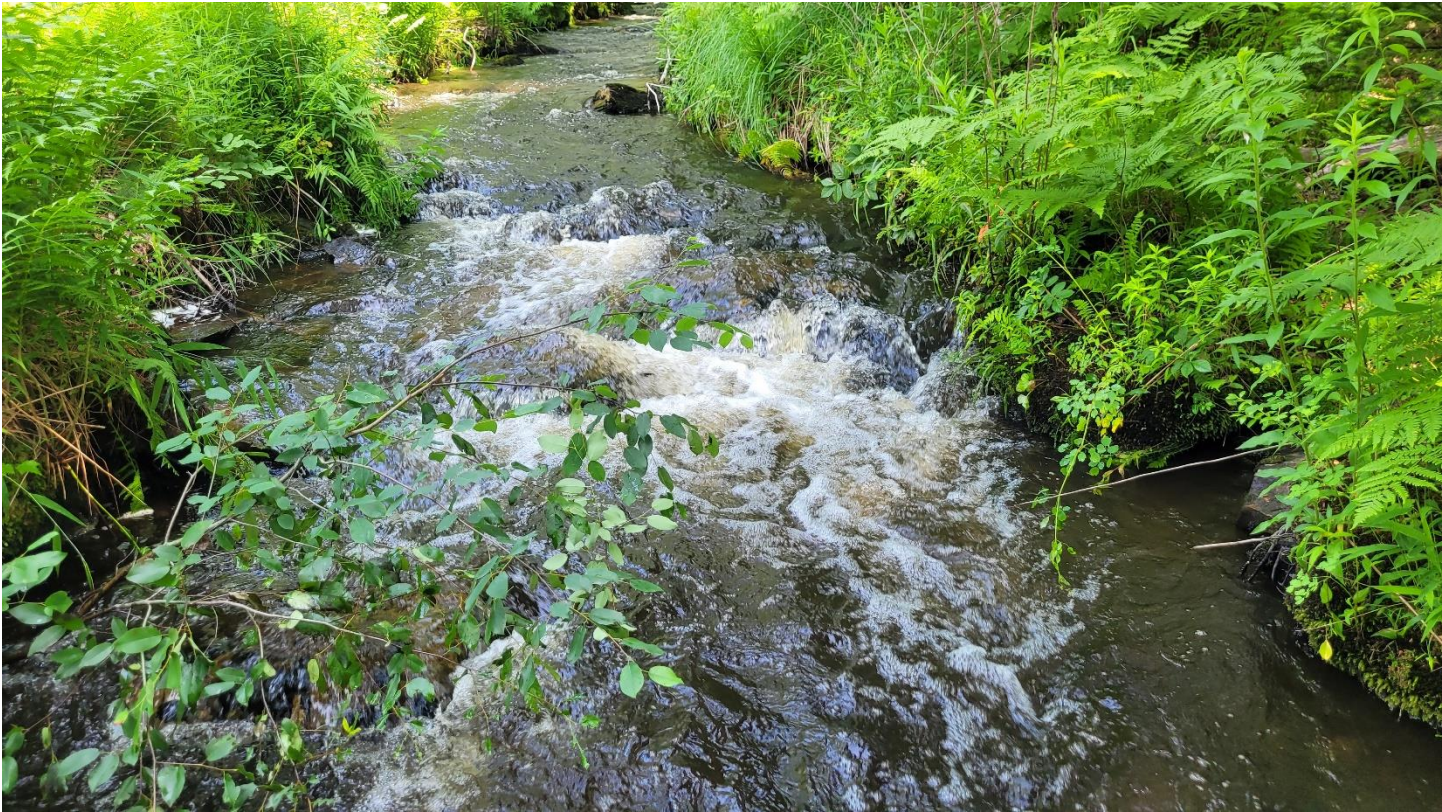
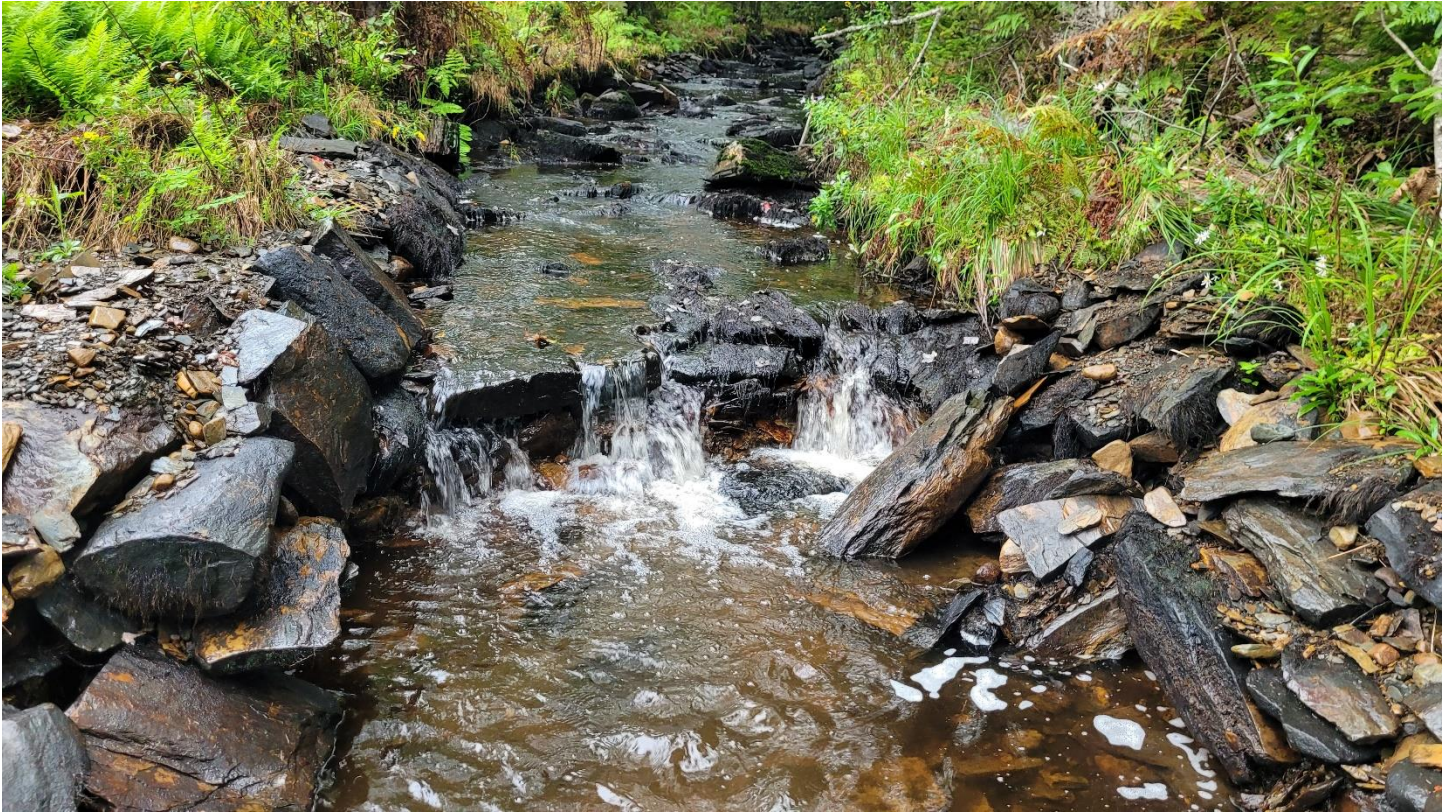
Site 2 – Rock sill 2 with deflector - before (above) and after (below)

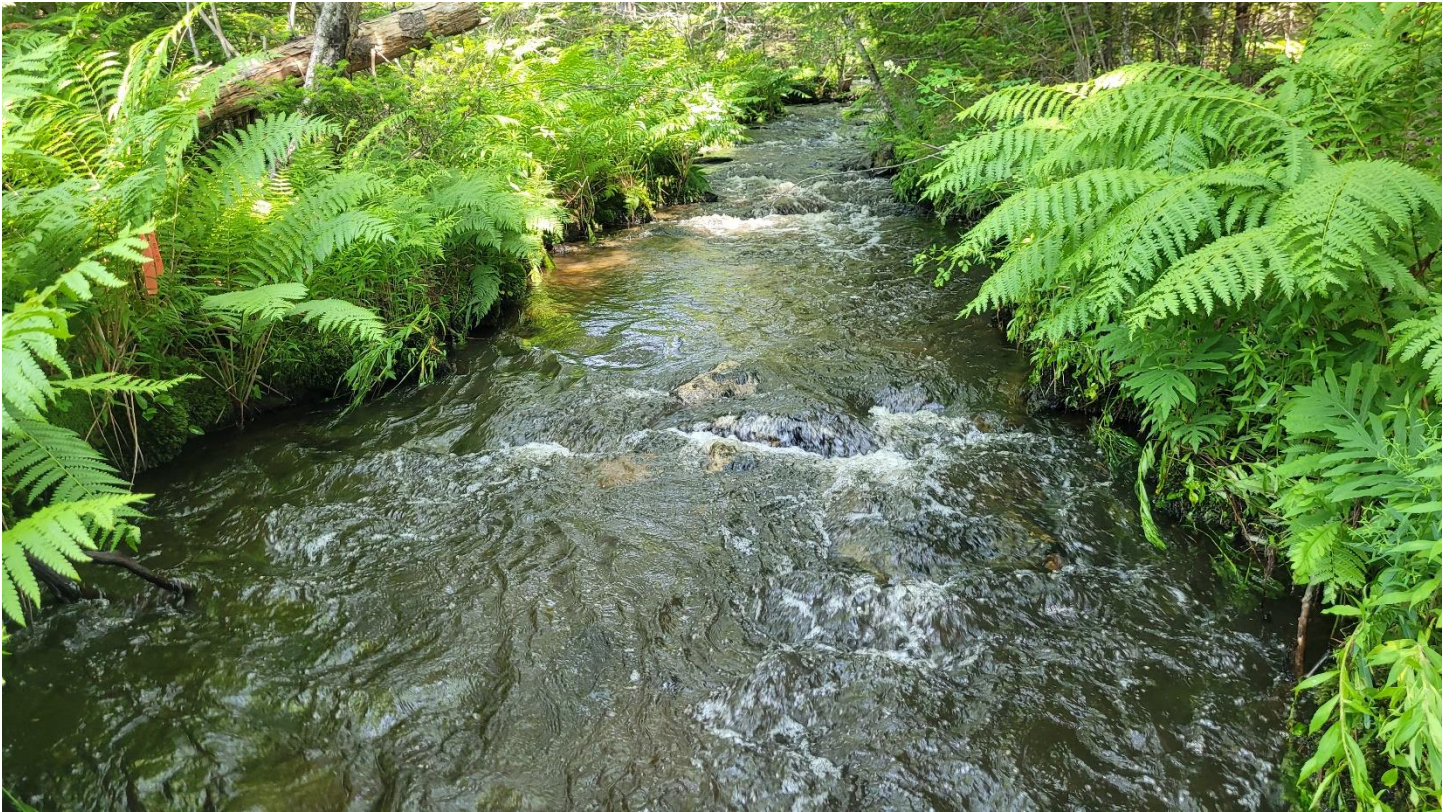
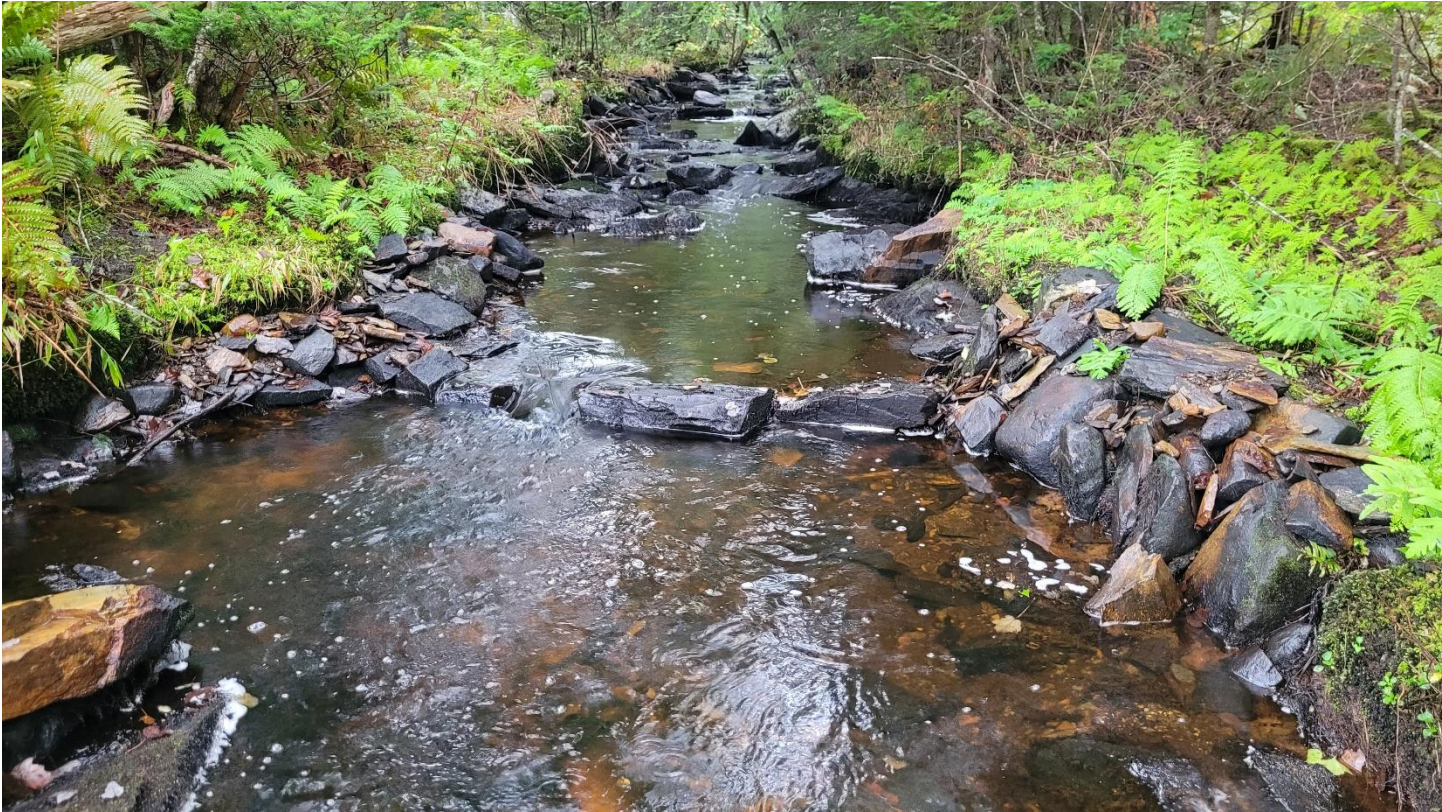
Site 3 – Rock sill 3 with deflector - before (above) and after (below)

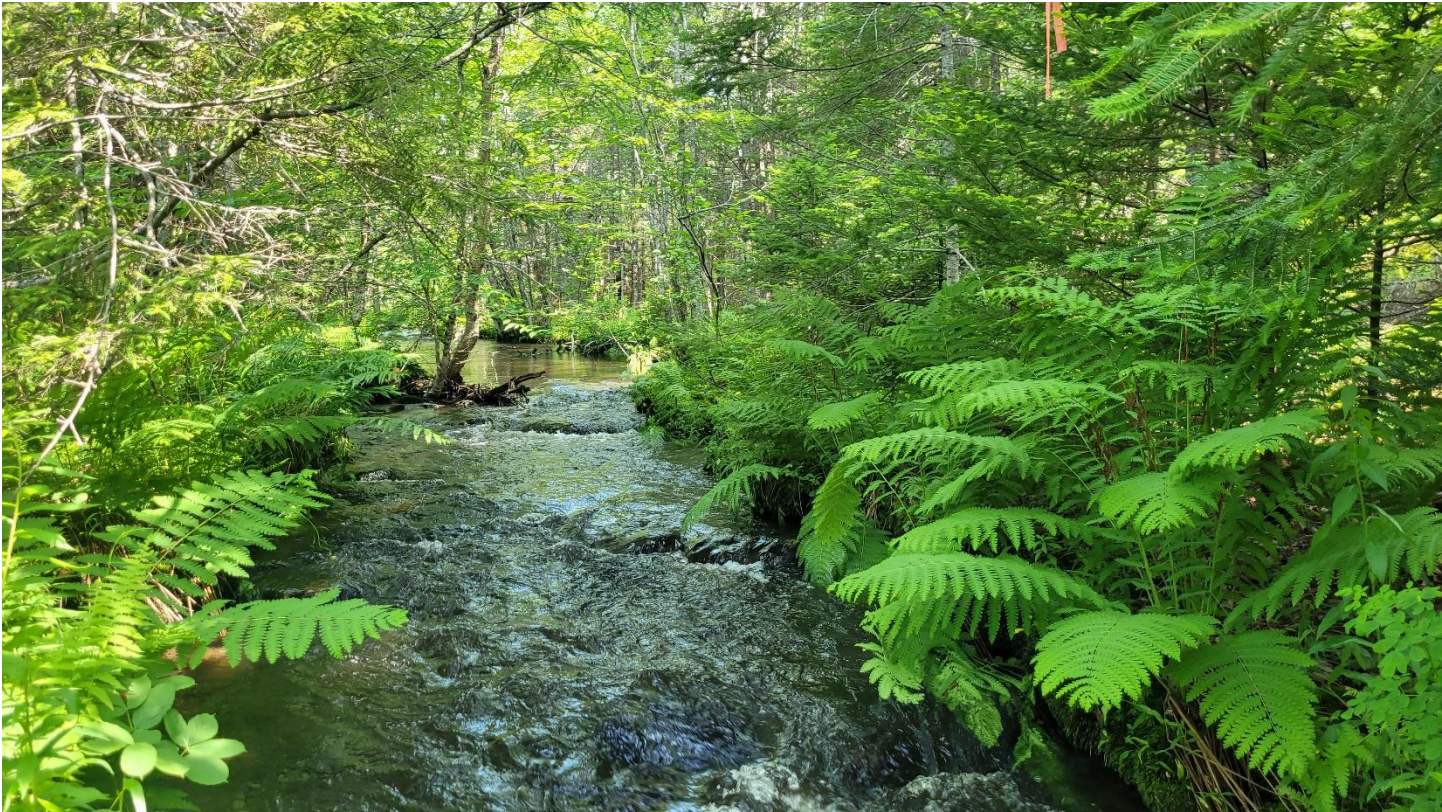
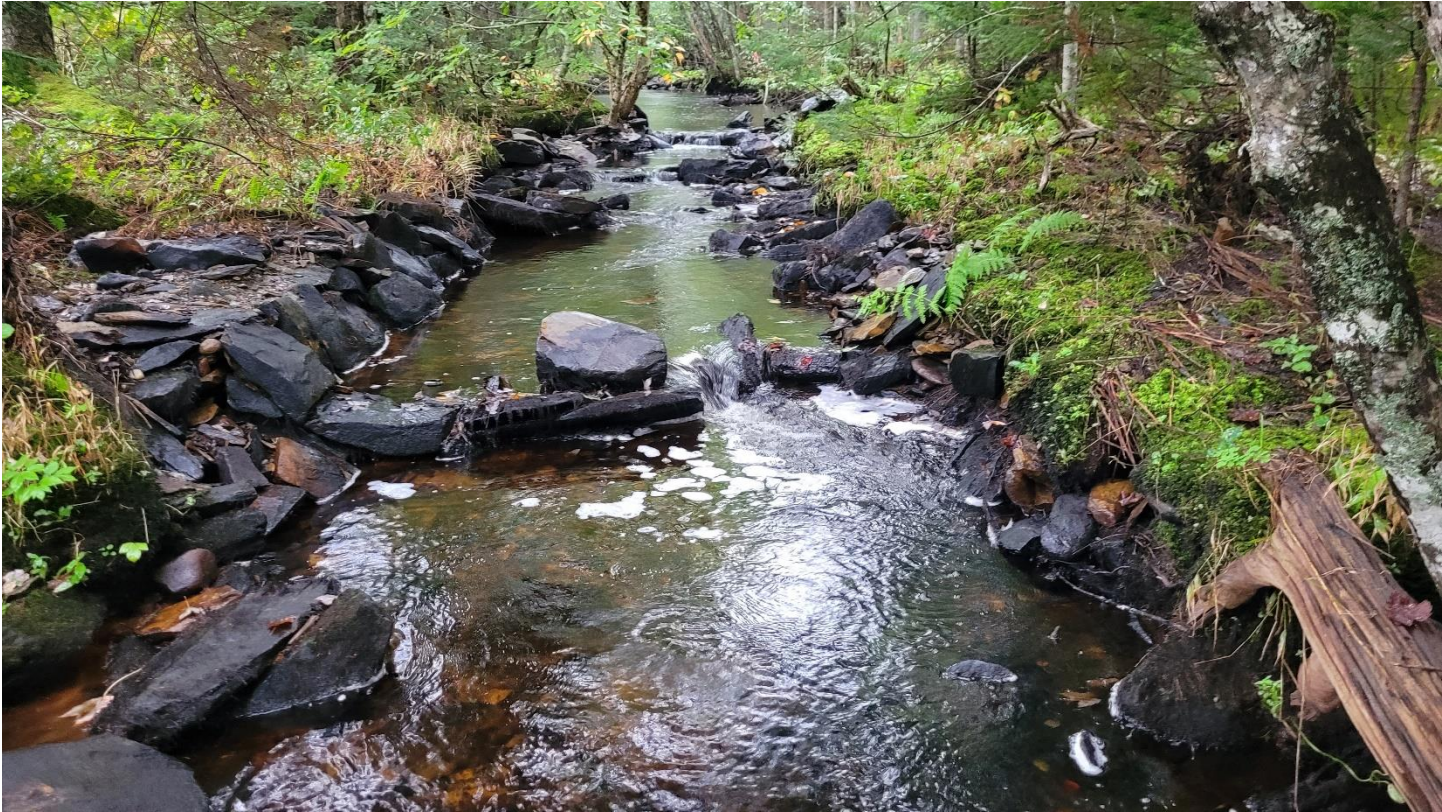
Site 4 – Rock sill 4 with deflector - before (above) and after (below)

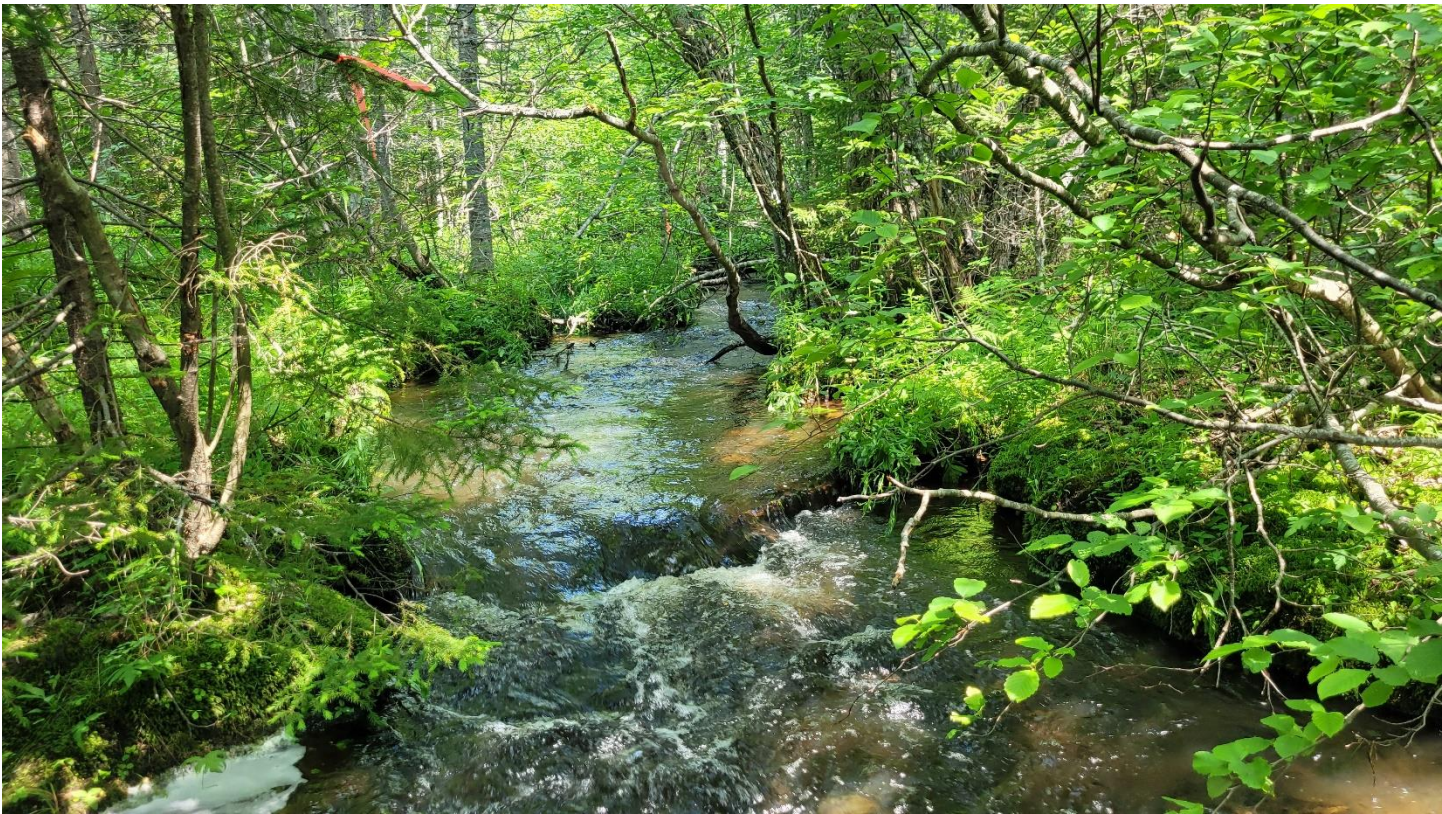
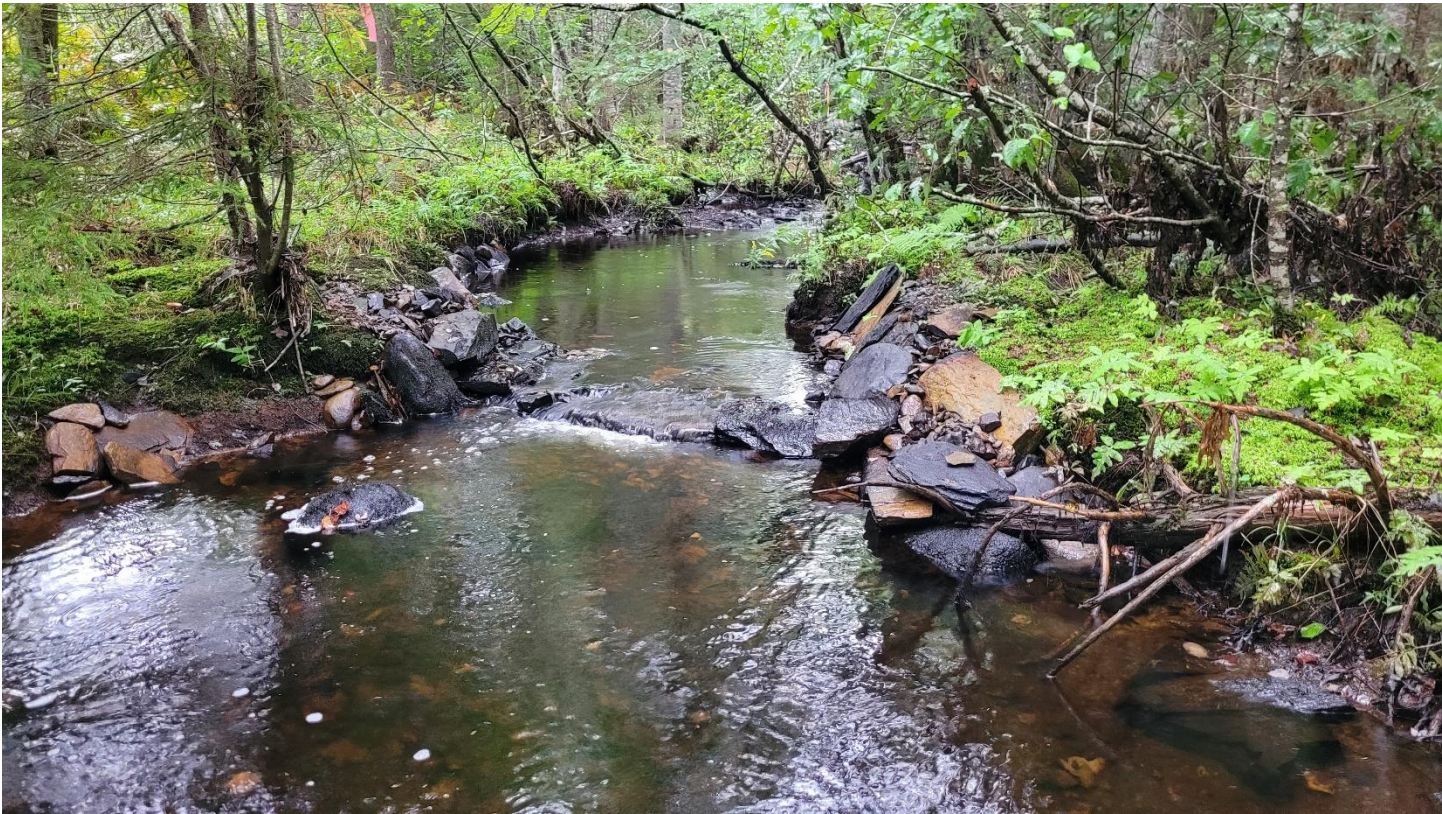
Site 5 – Rock sill 5 with deflector - before (above) and after (below)

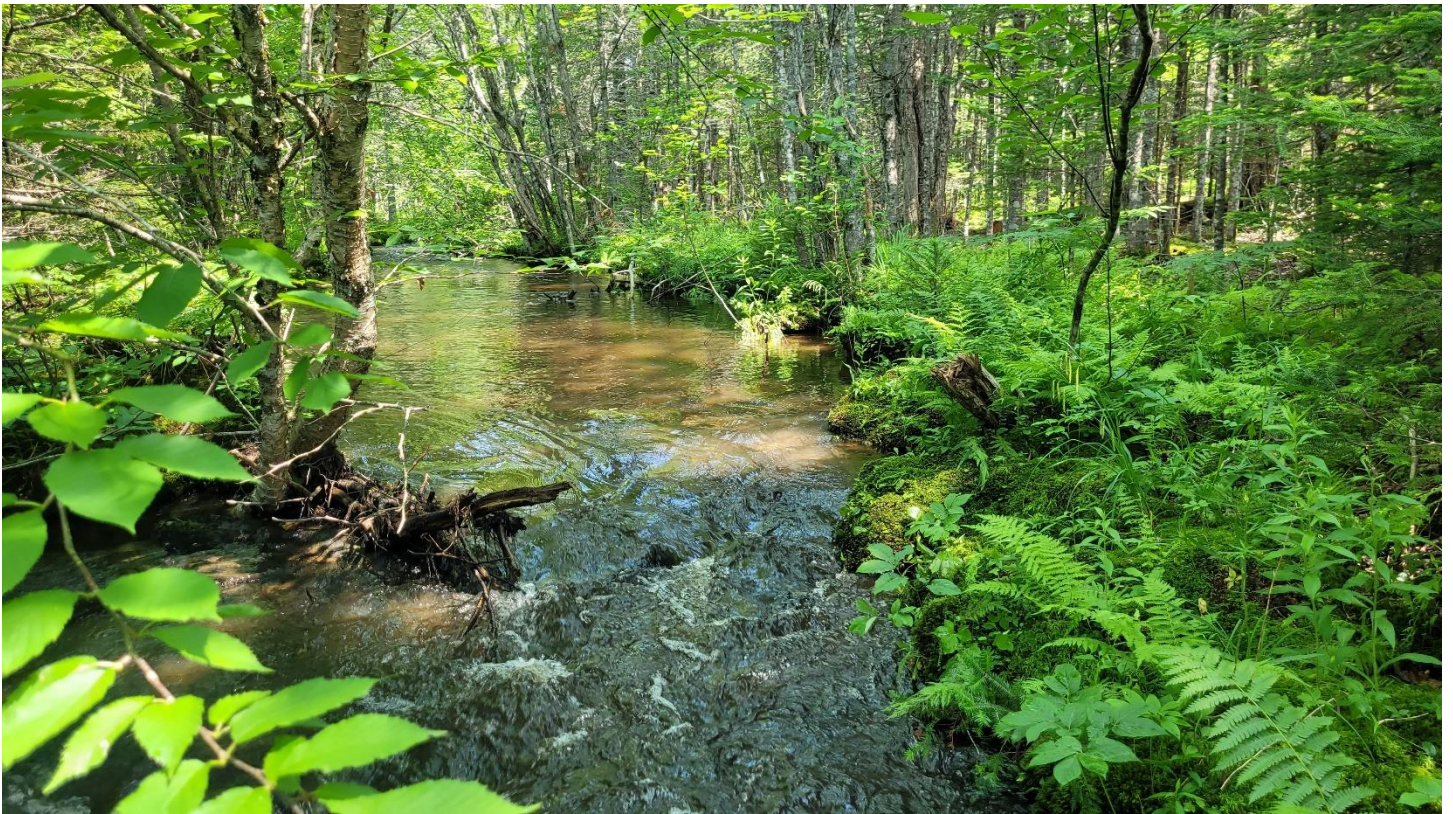
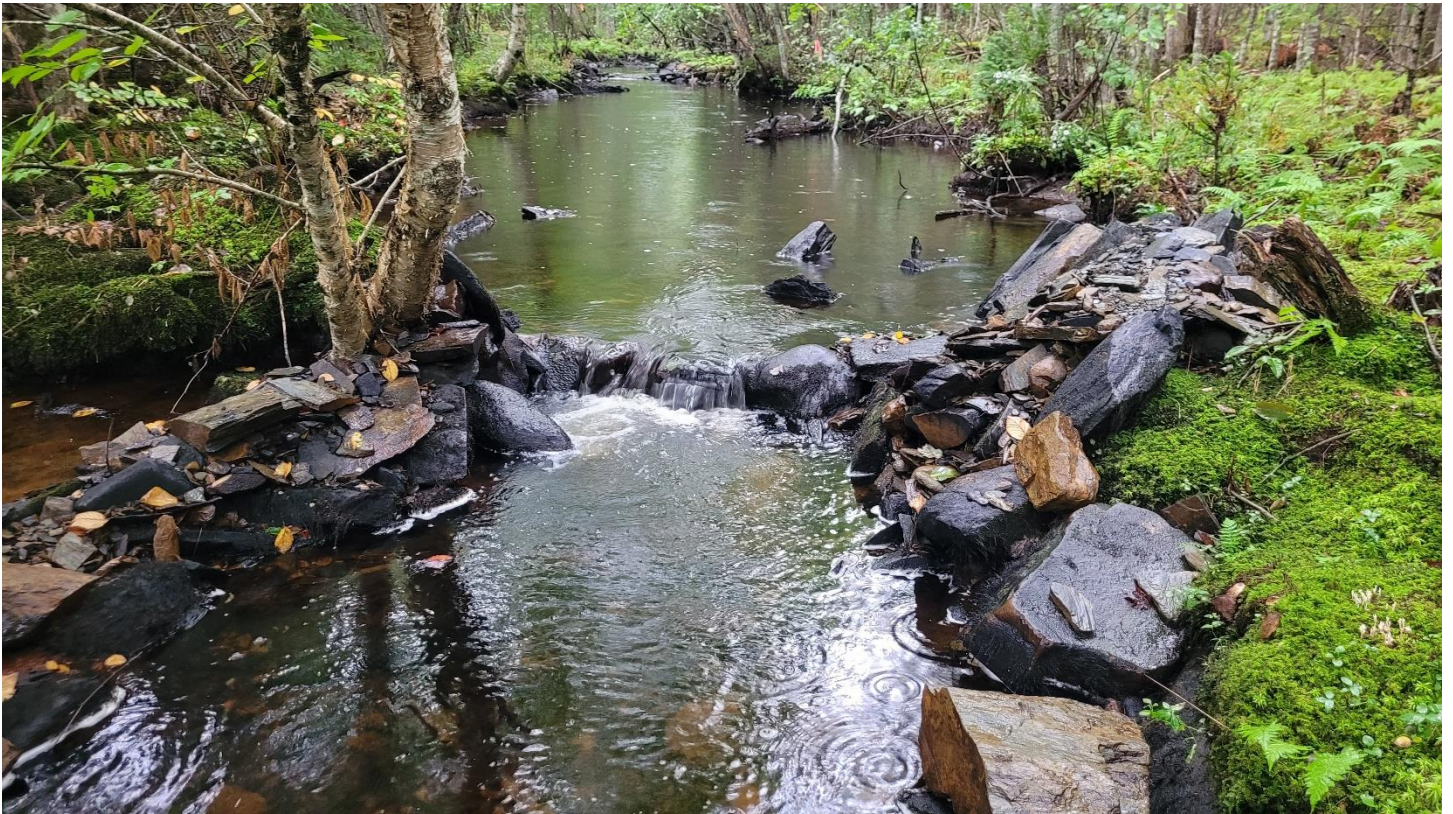
Site 6 – Rock sill 6 with deflector - before (above) and after (below)

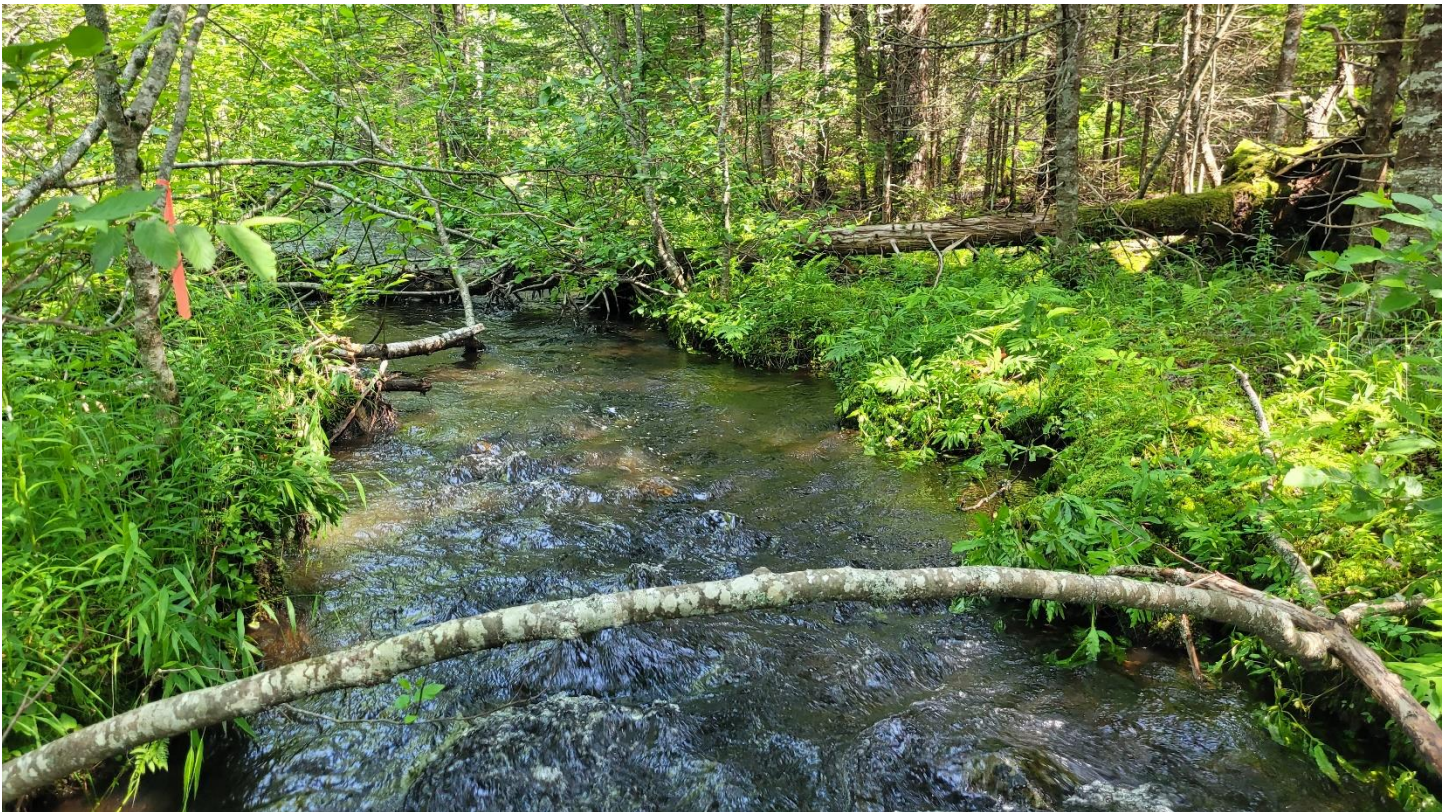
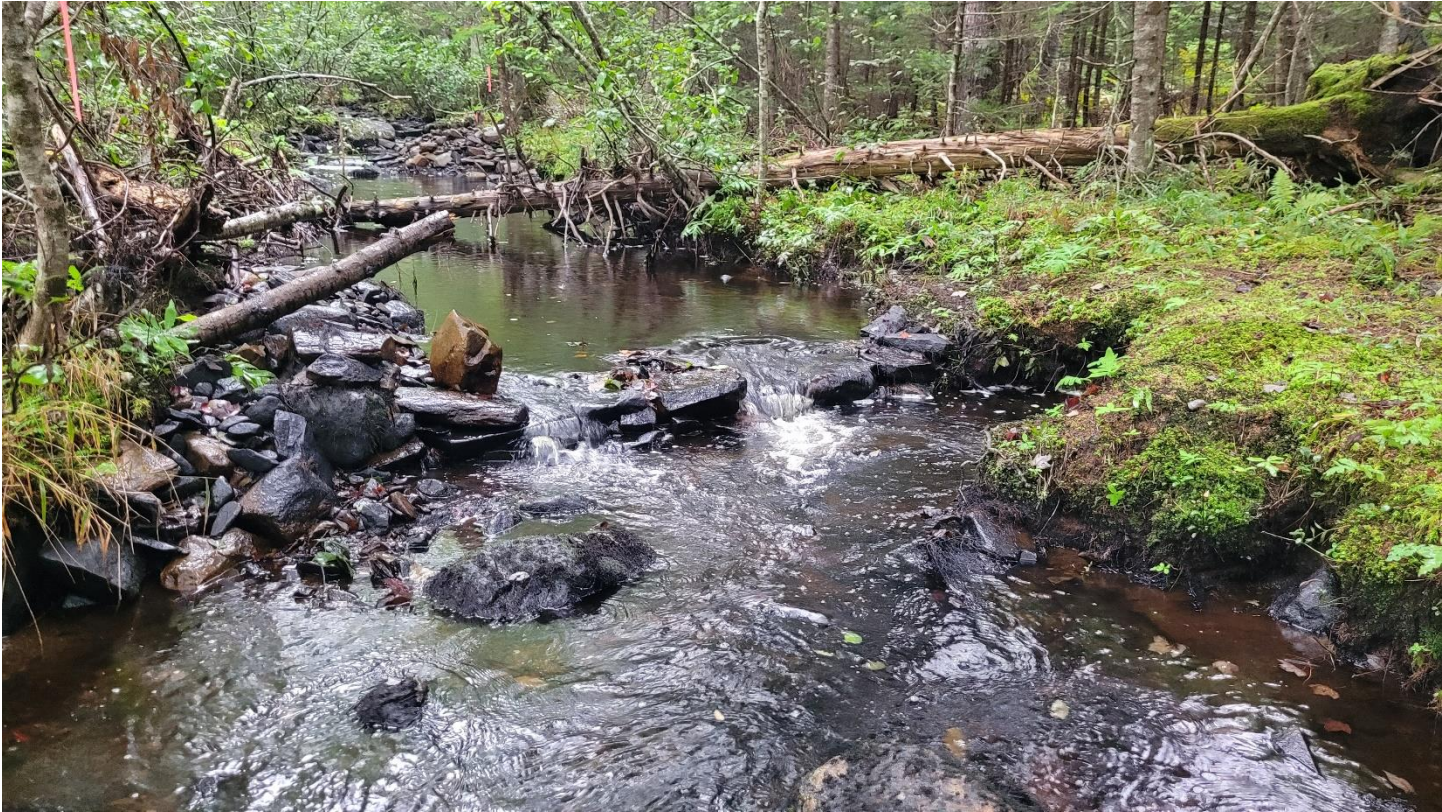
Site 7 – Rock sill 7 with deflector - before (above) and after (below)

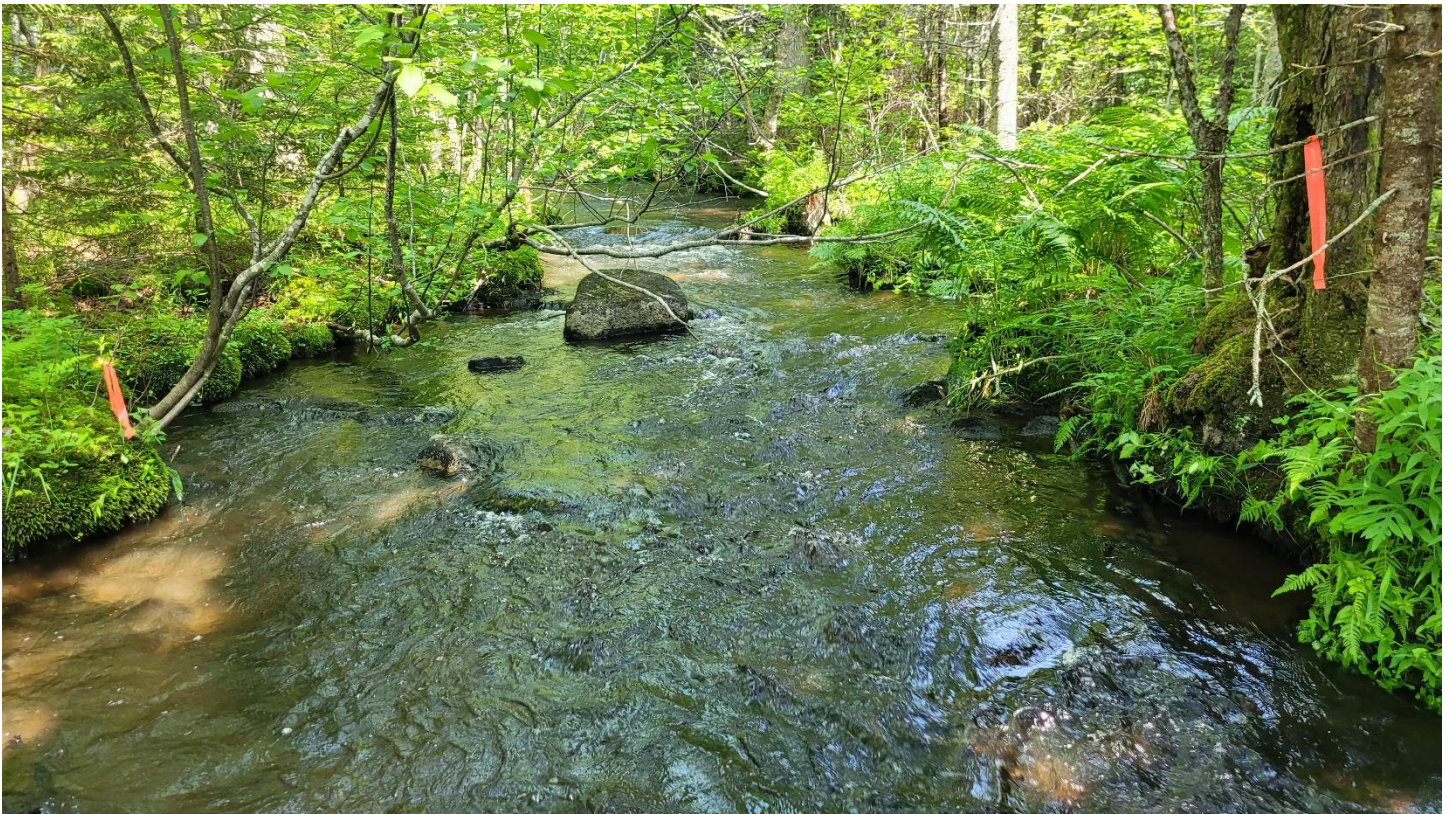
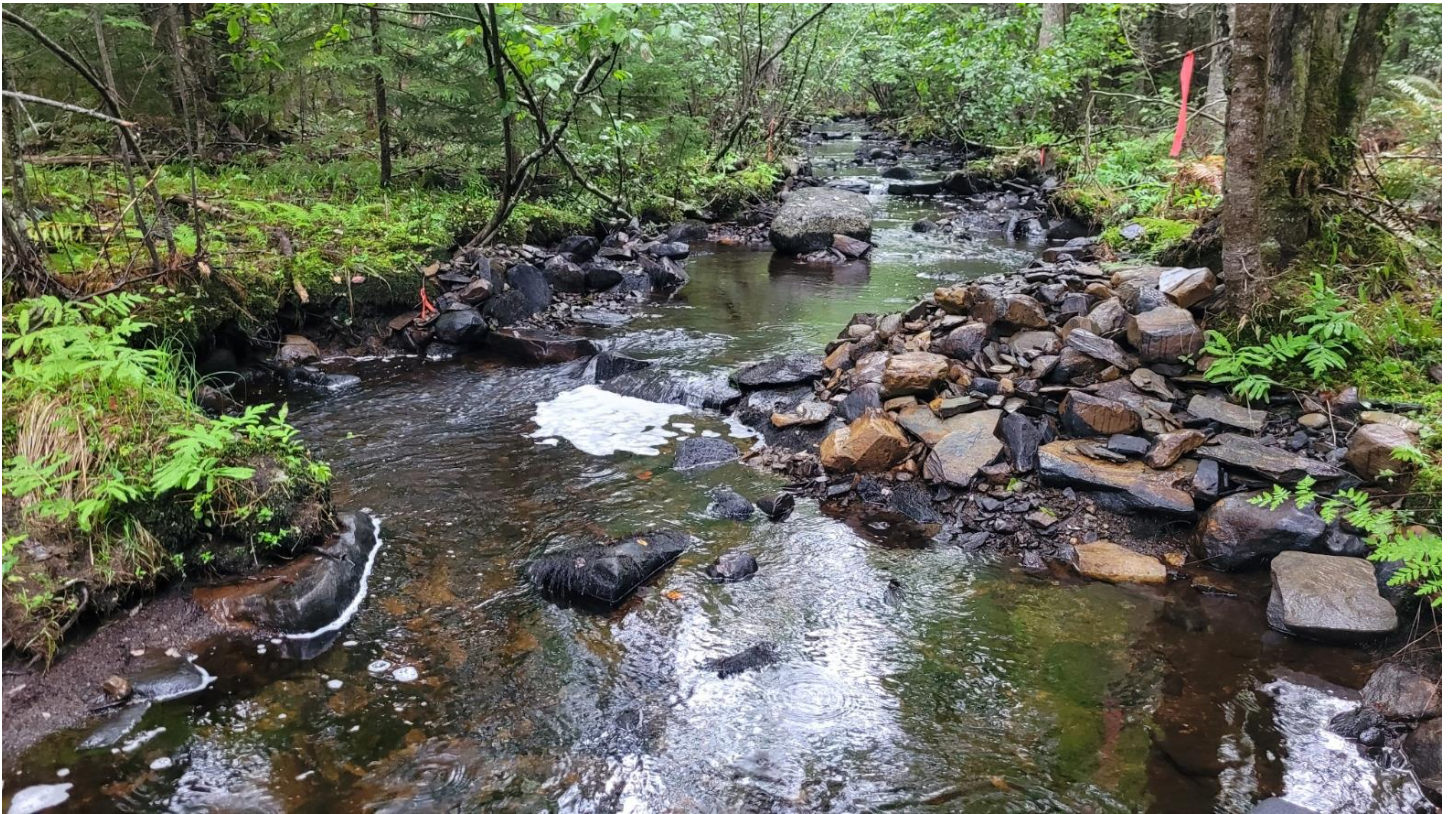
Site 8 – Rock sill 8 with deflector - before (above) and after (below)

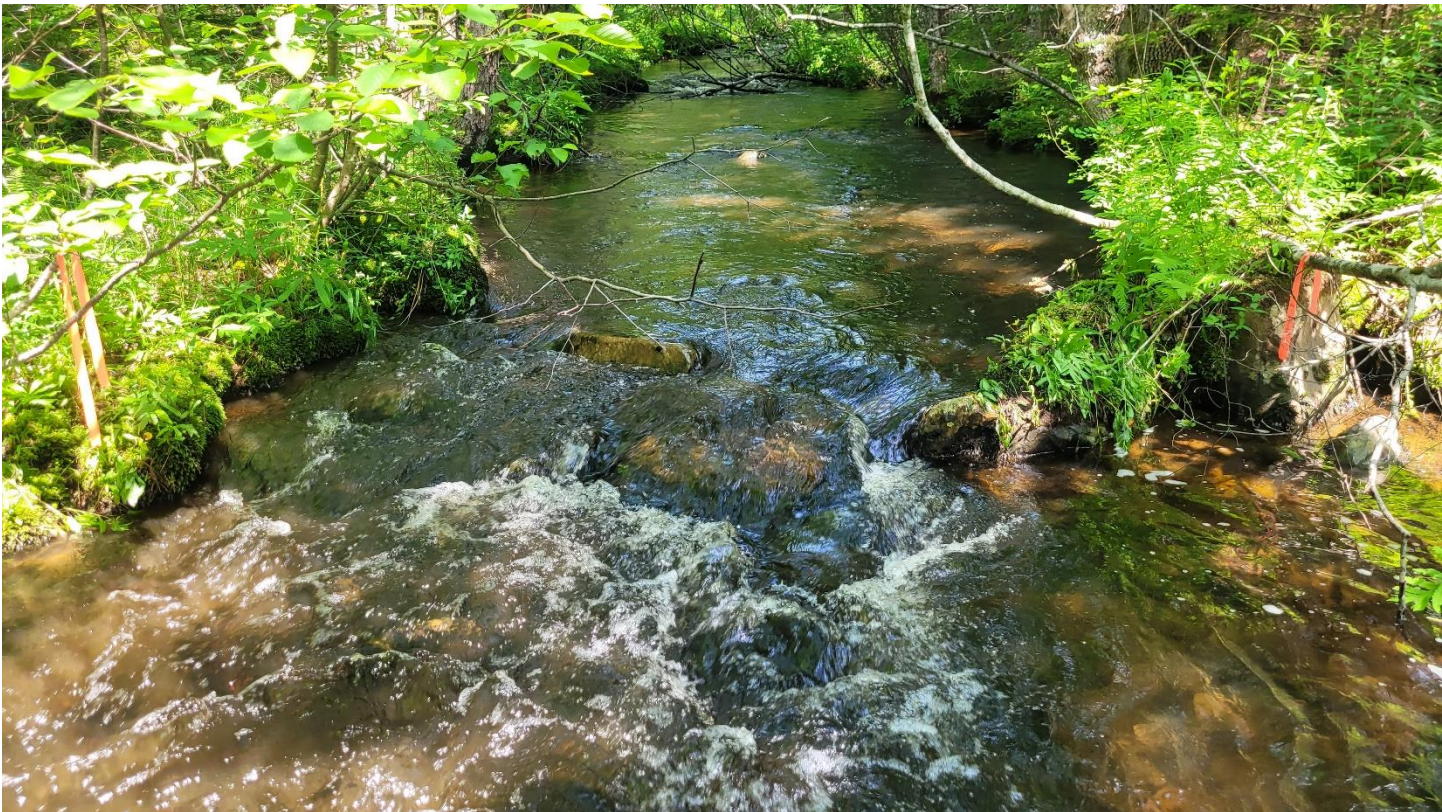
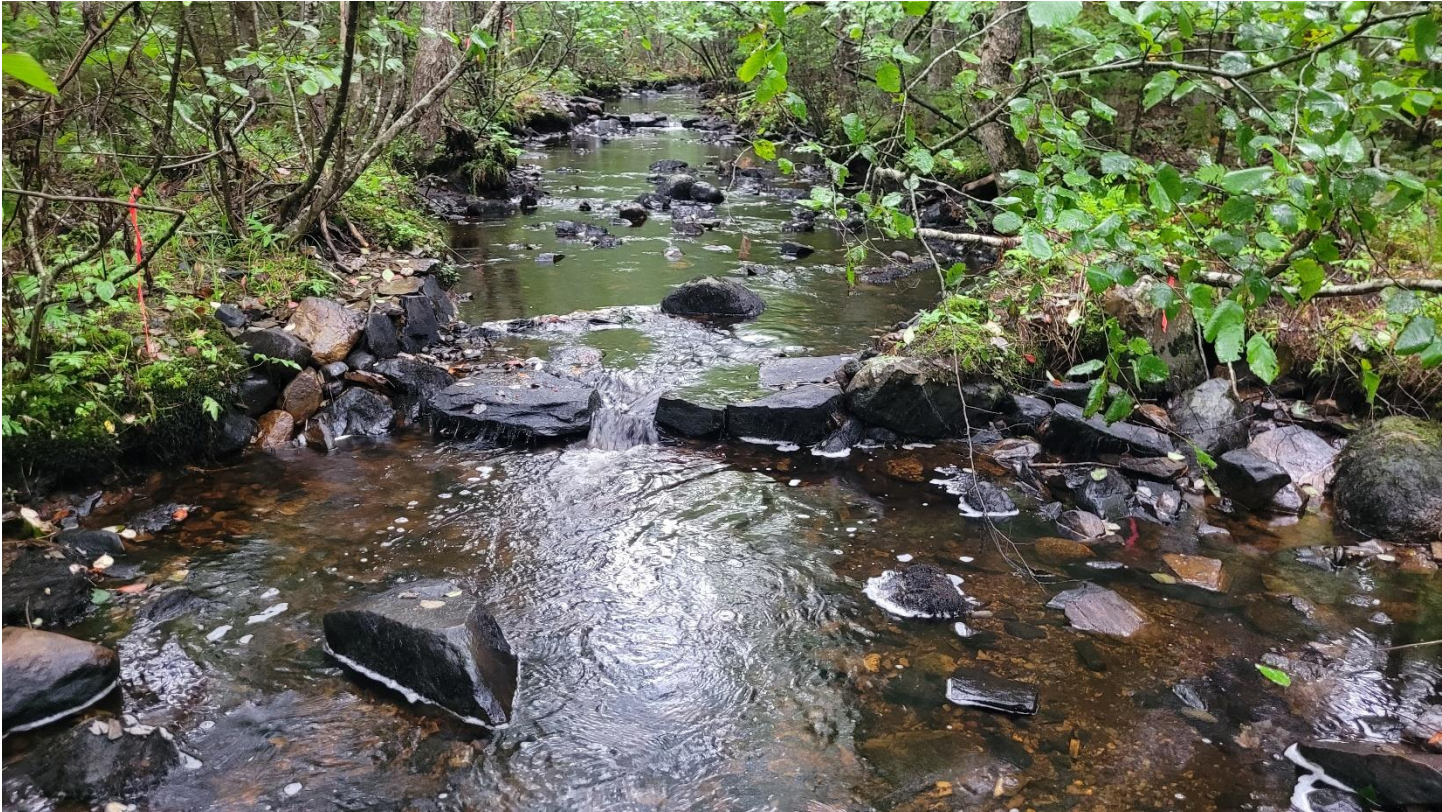
Site 9 – Rock sill 9 with deflector - before (above) and after (below)
