River Restoration 2023 Final Report  
December 2023

## **Introduction**

### **Drain Lake Brook**

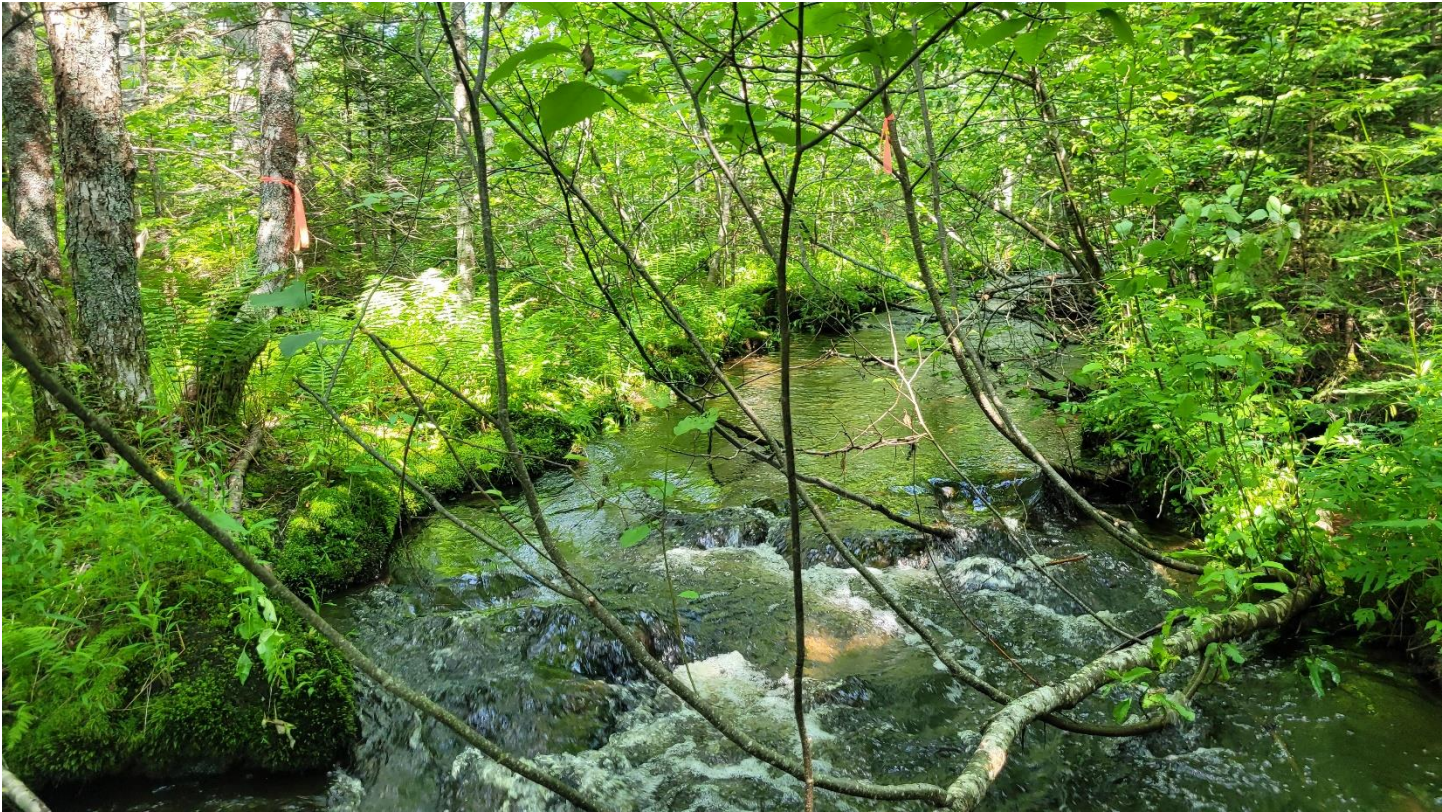
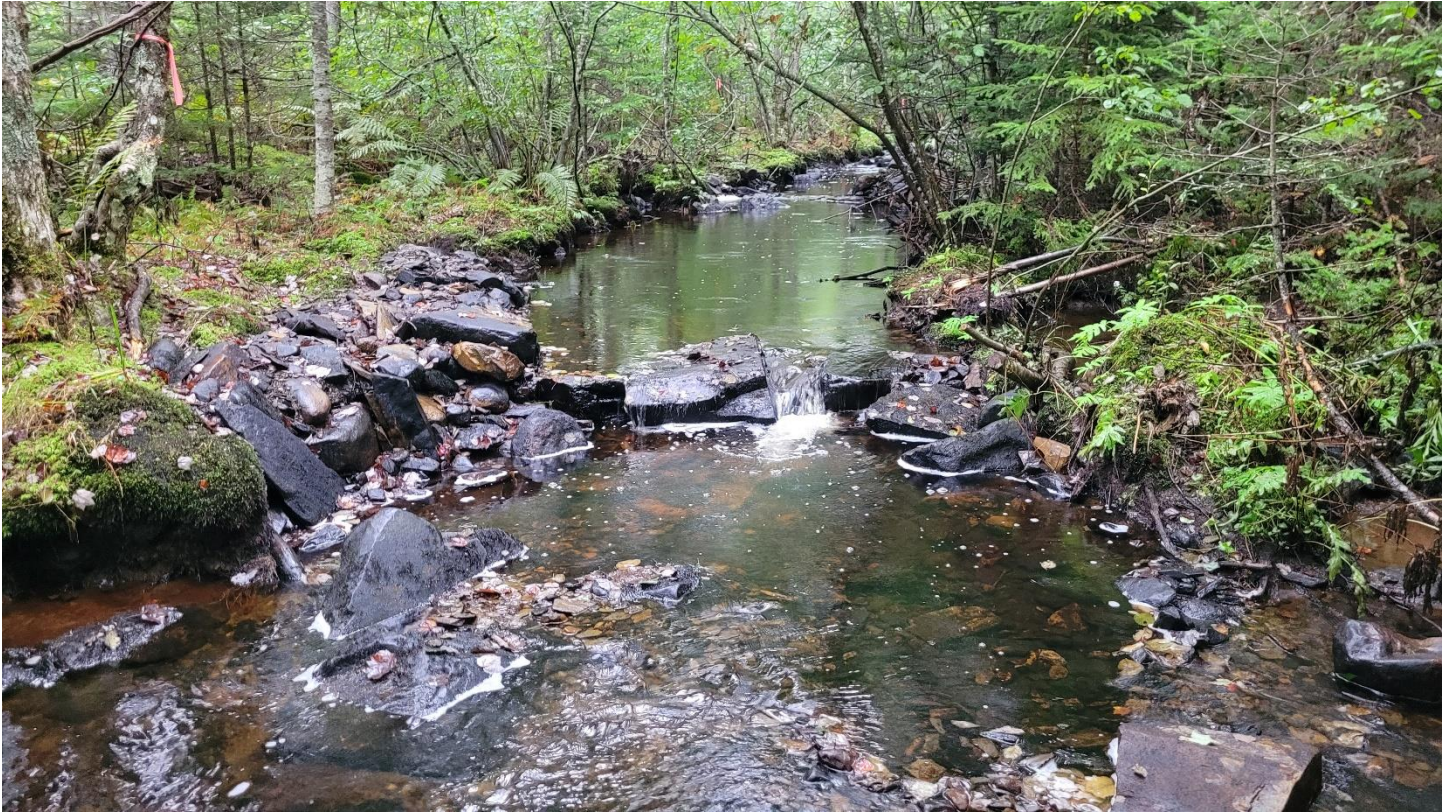
Site 10 – Diggerlog 10 with deflector - before (above) and after (below)

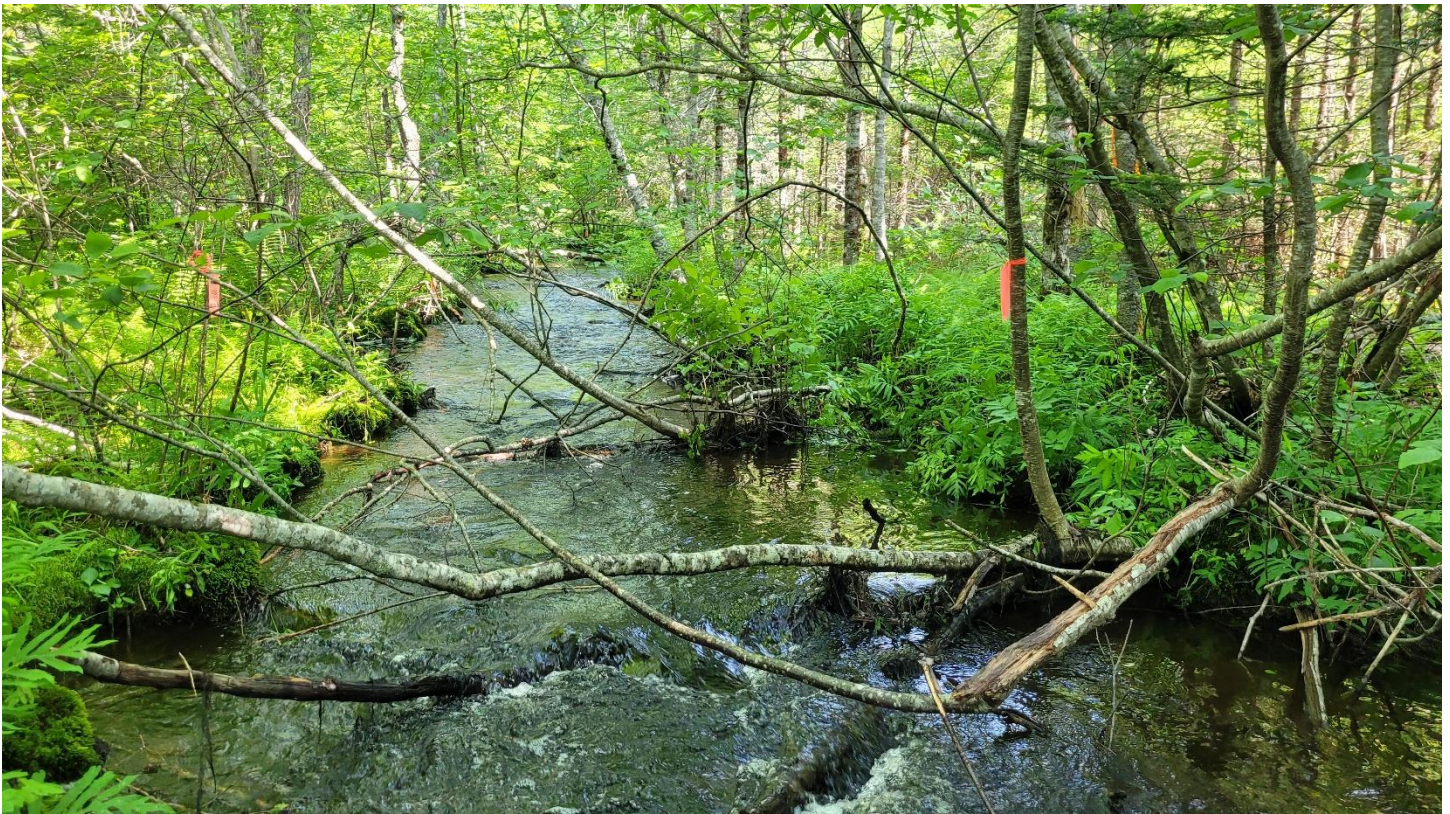
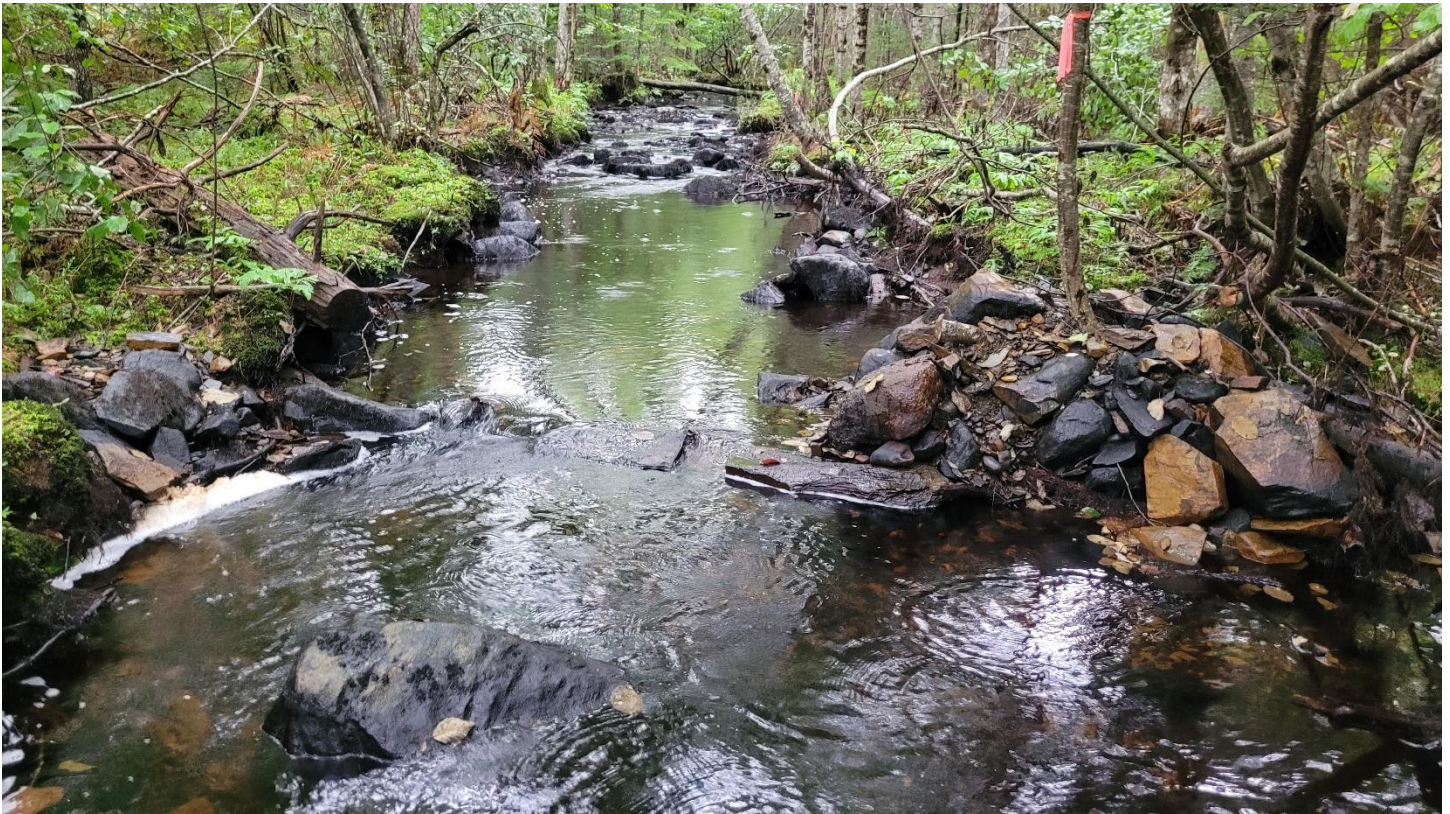
Site 11 – Rock sill 11 with deflector - before (above) and after (below)

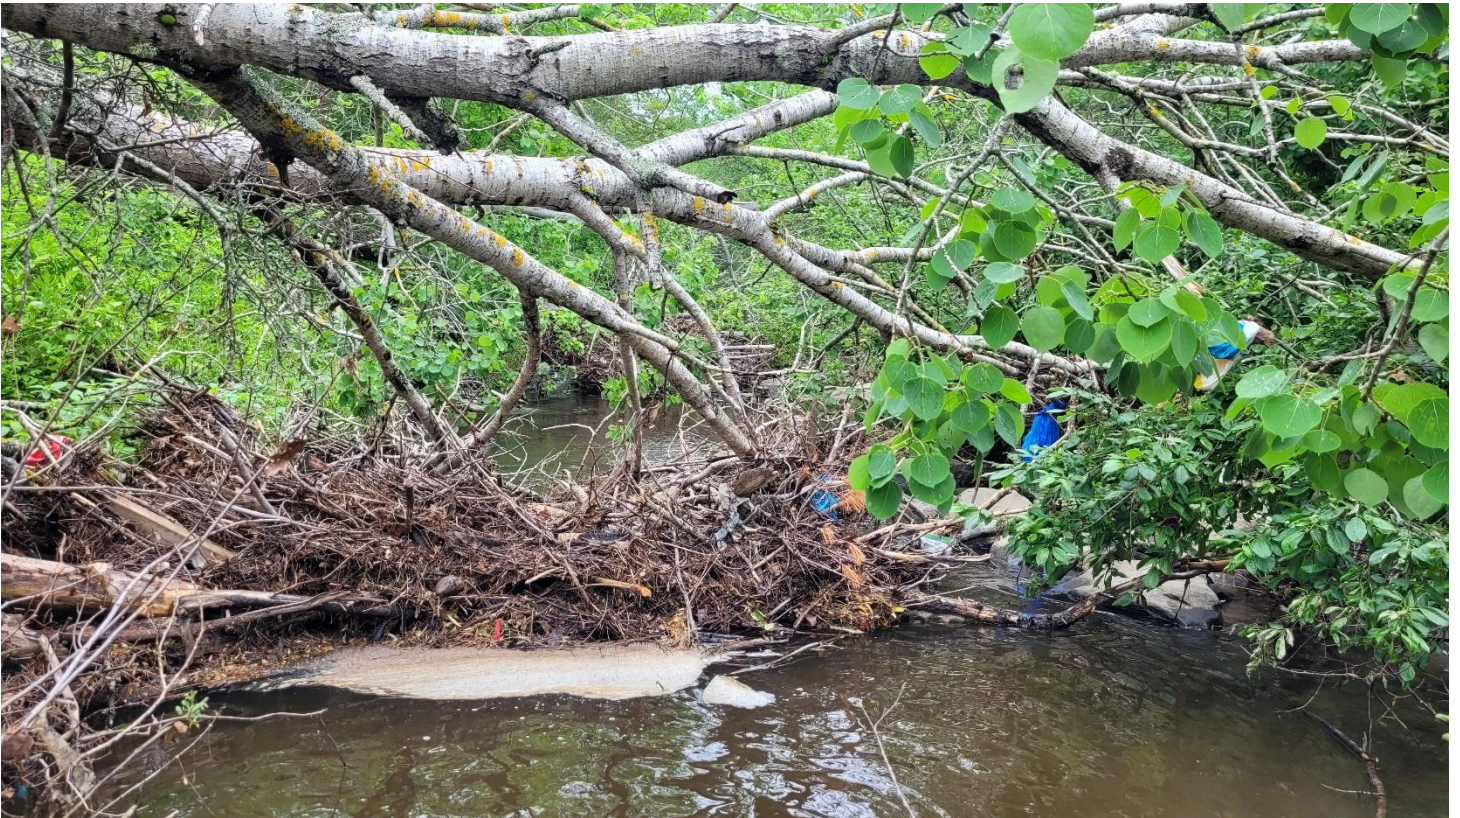
Debris jam cleared on Drain Lake Brook

This project also restored fish access to 1.5km of habitat by removing several solid blockages to fish passage near the bottom of Drain Lake Brook between McCabe Lake and Drain Lake. As part of tis project, we had also removed several large debris blockages on the Little Sackville River – one of two most important tributaries to the main Sackville River, and the most important salmon-rearing habitat due to the higher pH of the waters in the Little Sackville River. These blockages, several of which were complete blockages to fish passage, were a result of Hurricane Fiona from the Fall of 2022. These blockage removals had resulted in the return of fish passage to more than 3 kilometers of upstream habitat and two headwater lakes on the Little Sackville River
