River Restoration 2025 Final Report

December 2025

Sackville Rivers Association's River Restoration 2025 project had provided fish habitat restoration and other work on Drain Lake Brook in the Sackville River watershed – in the community of Middle Sackville (Indigo Shores).

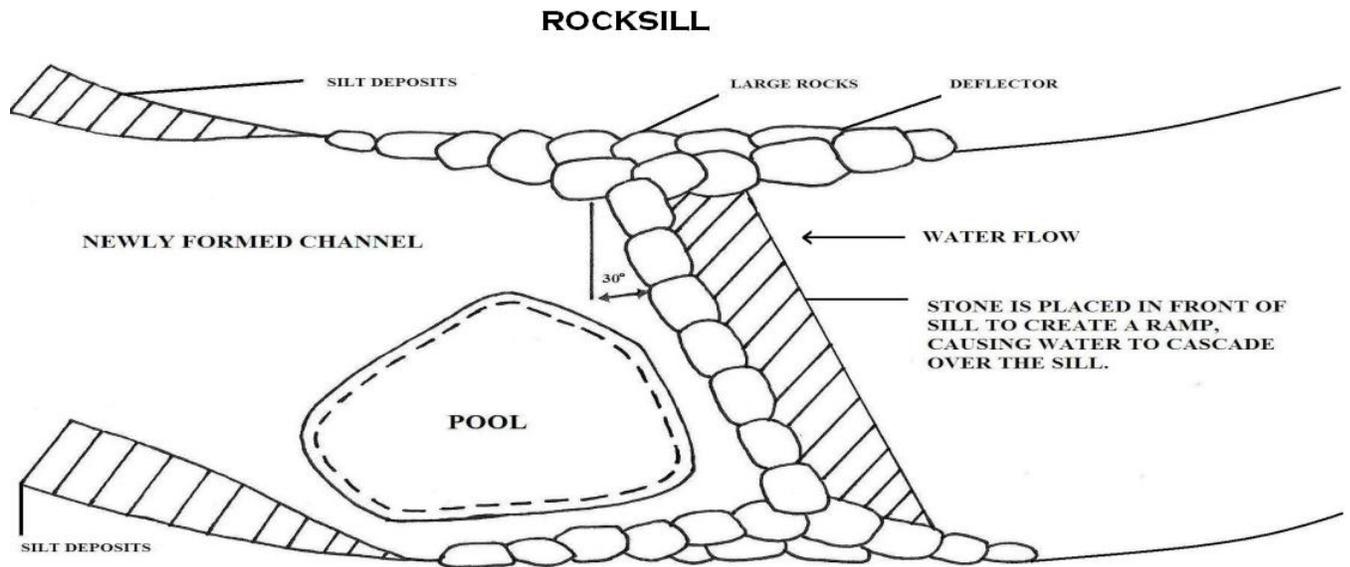
General rock sill specification

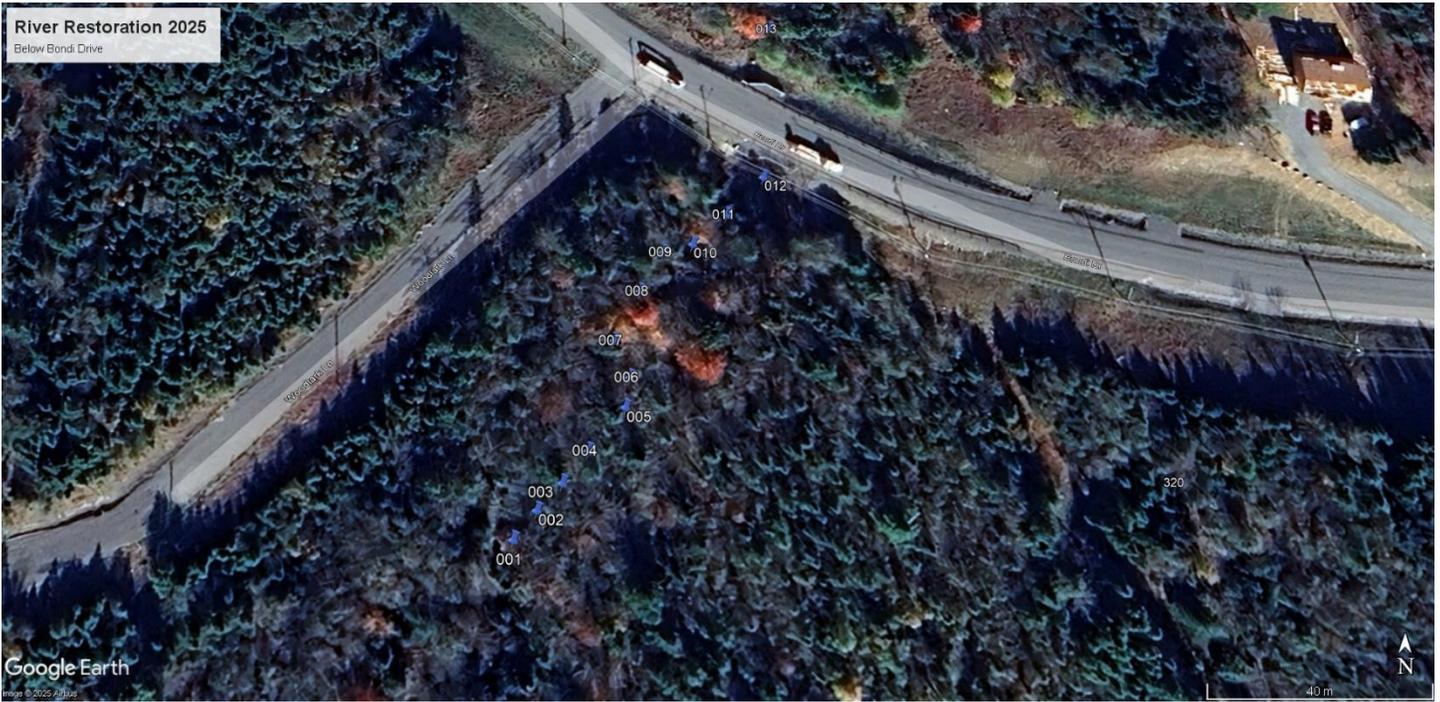
River Restoration 2025 – Drain Lake Brook habitat restoration installations (sites 1 through 12 – 12 rock sills and 10 deflectors, with 2 side channel blockages).

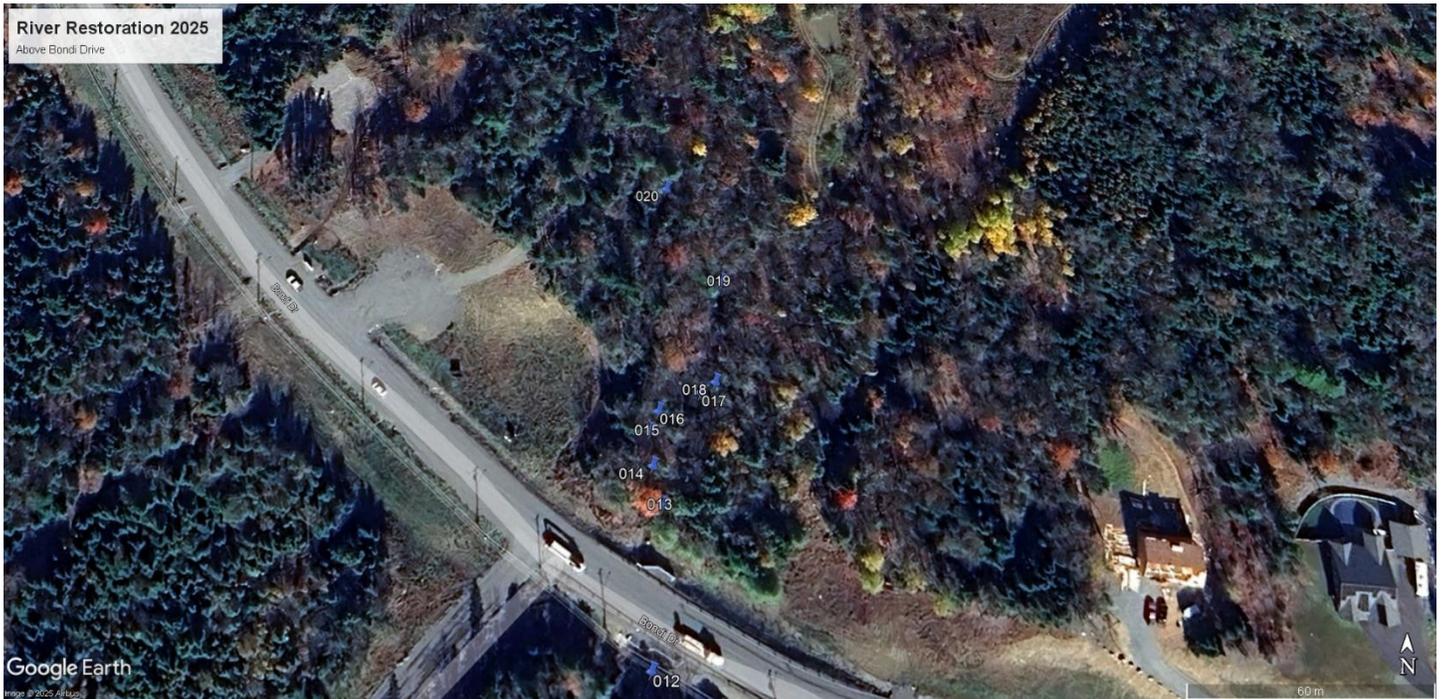
River Restoration 2025 – Drain Lake Brook habitat restoration installations (sites 13 through 20) – 8 rock sills (2 were adjustments of existing rock formations) and 3 deflectors).

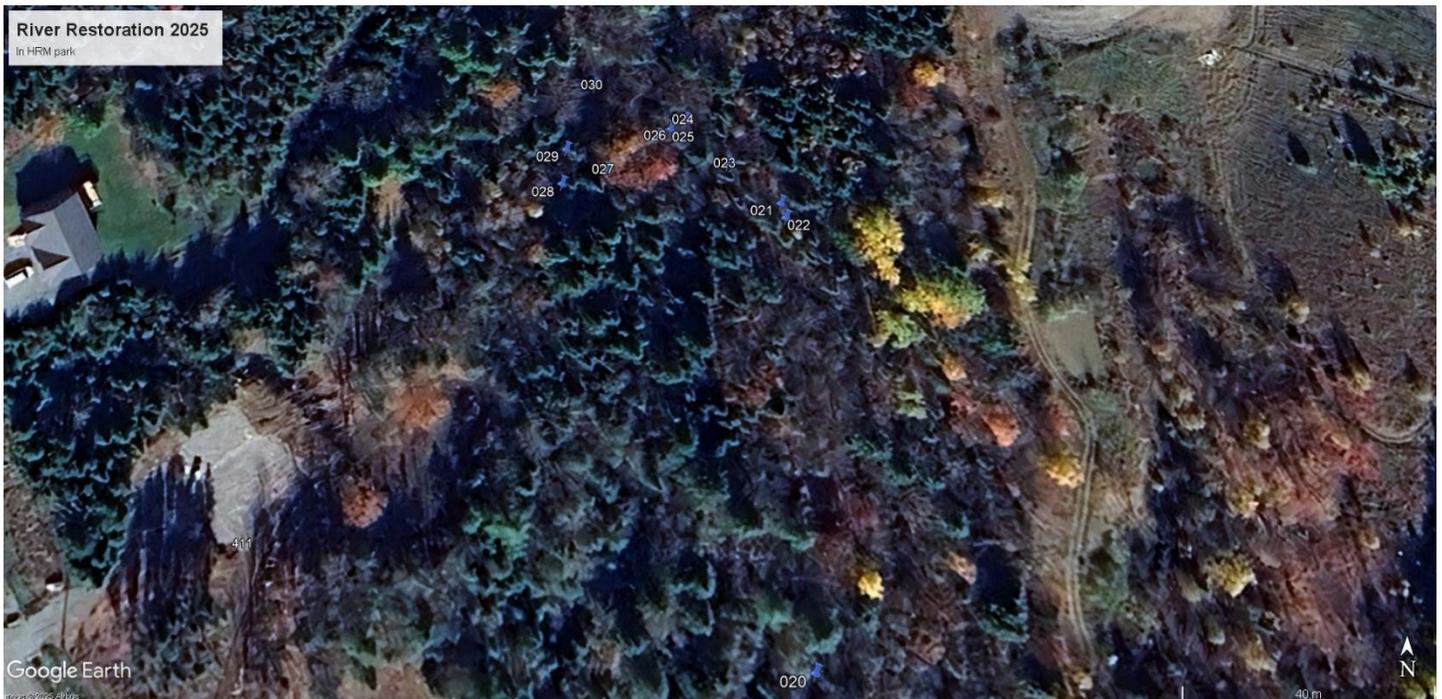
River Restoration 2025 – Drain Lake Brook habitat restoration installations (sites 21 through 30) – 10 rock sills (1 was adjustment of an existing rock formation) and 10 deflectors).

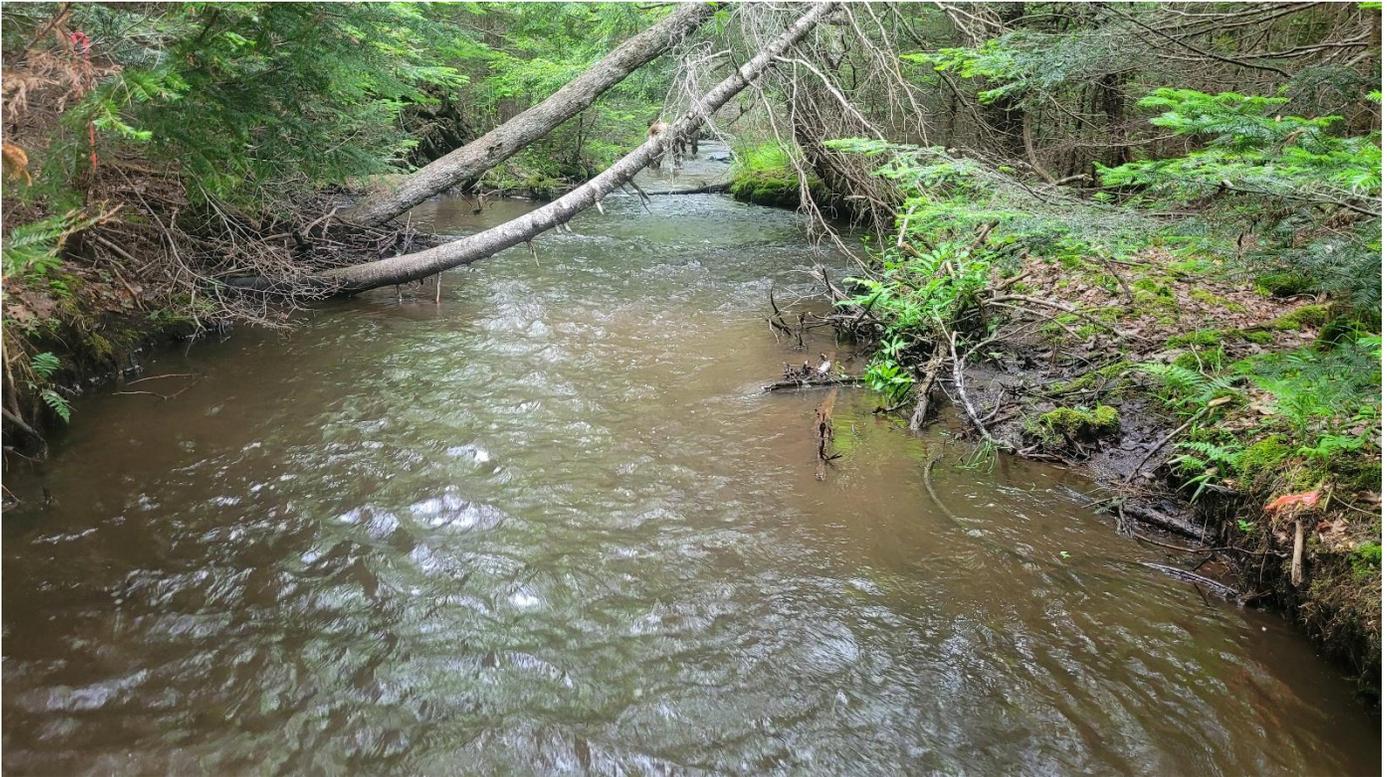
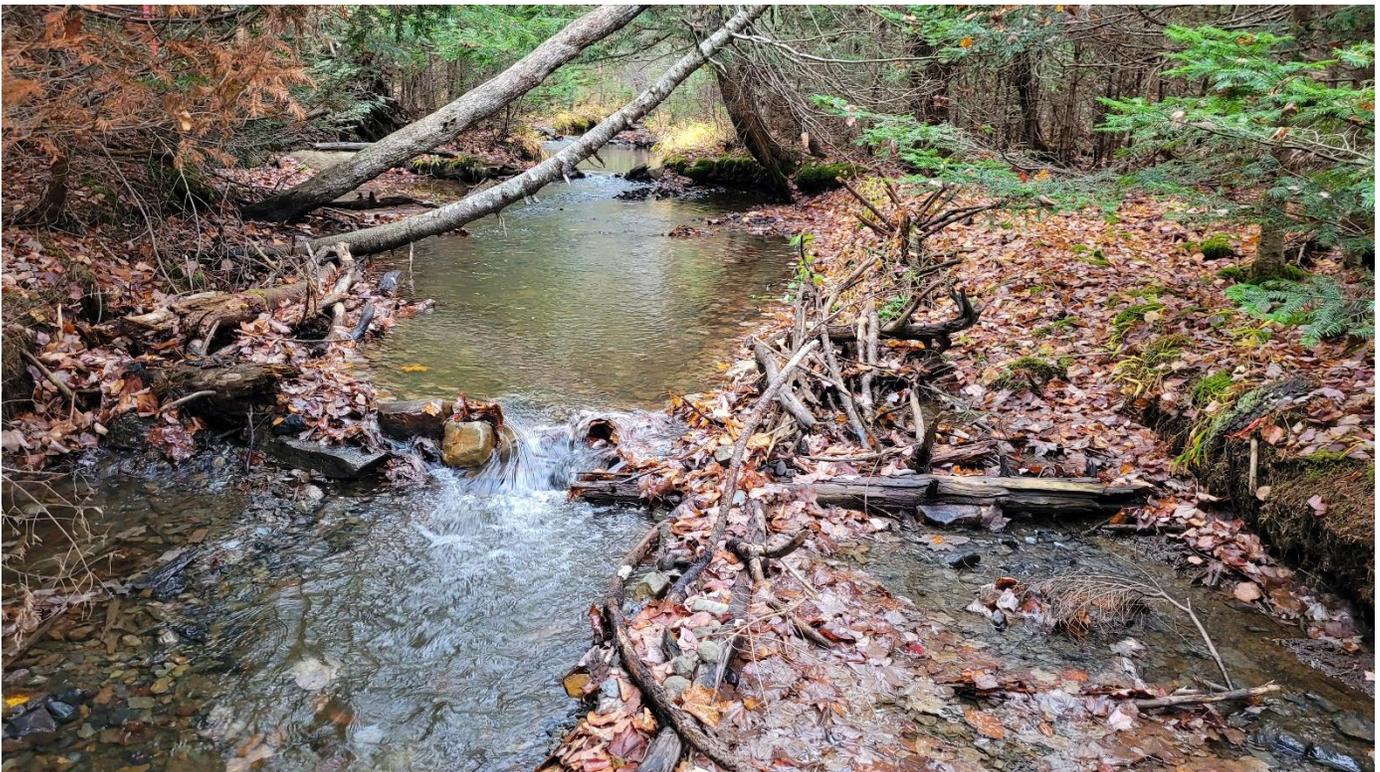
Site 1 – Rock sill with deflector - before (above) and after (below)

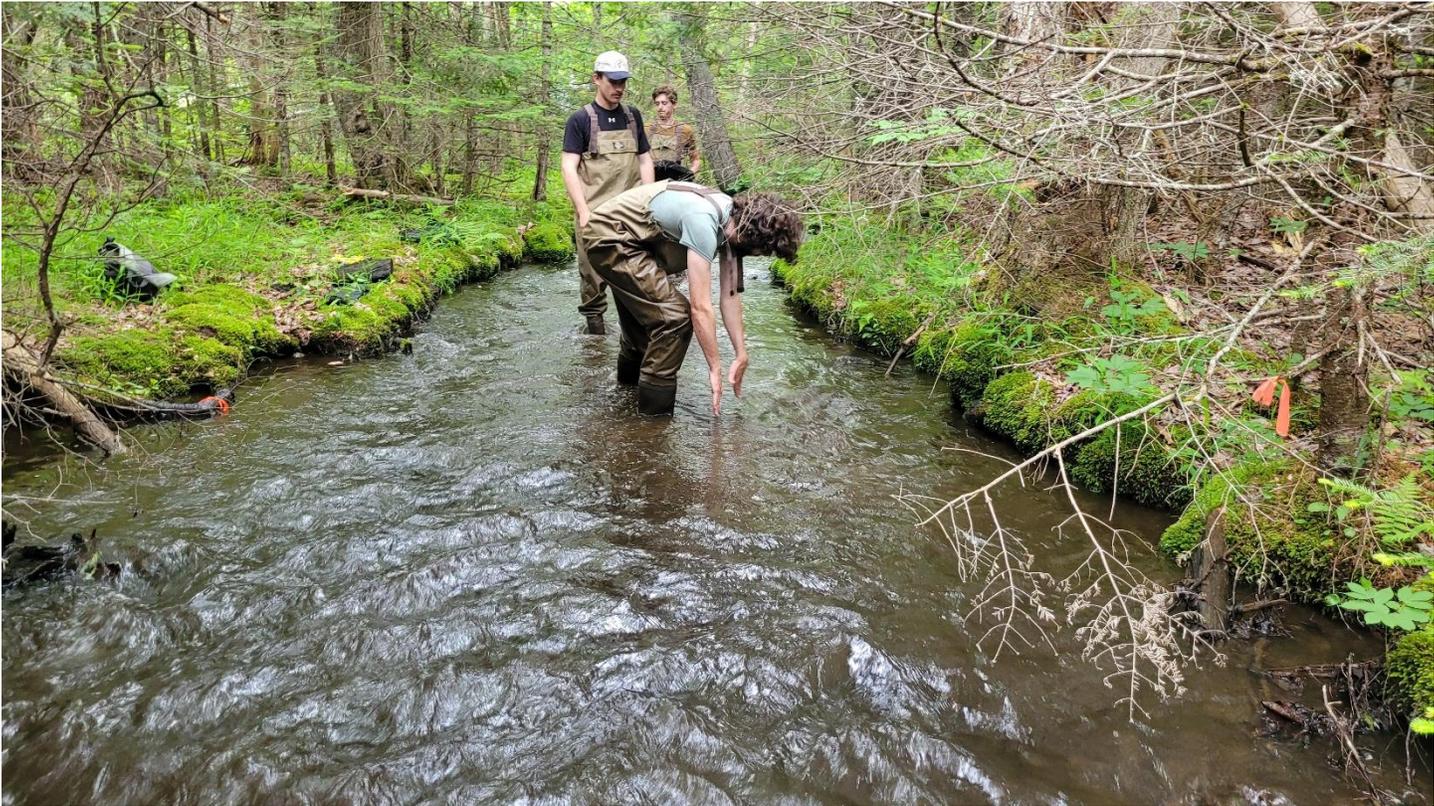
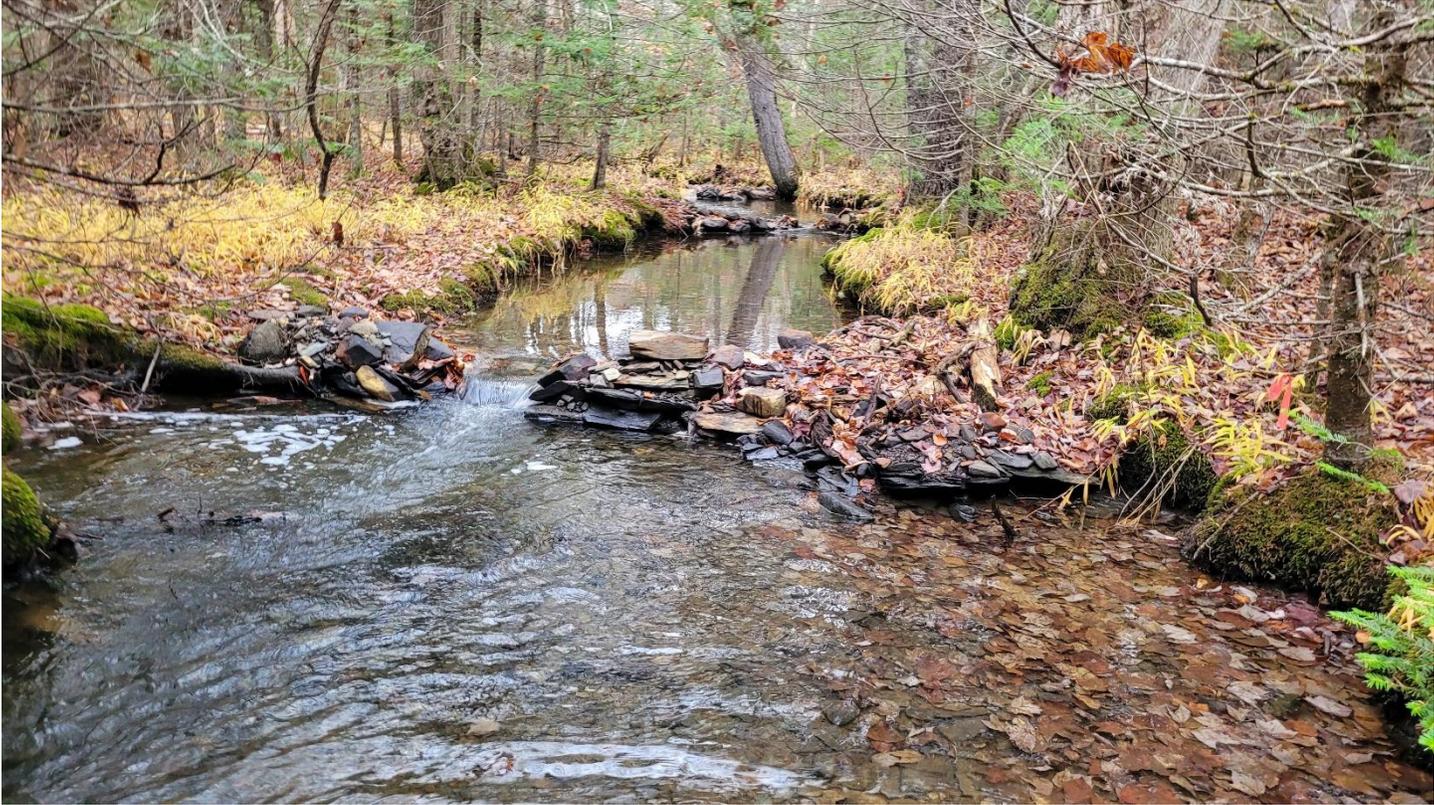
Site 3 – Rock sill with deflector - before (above) and after (below)

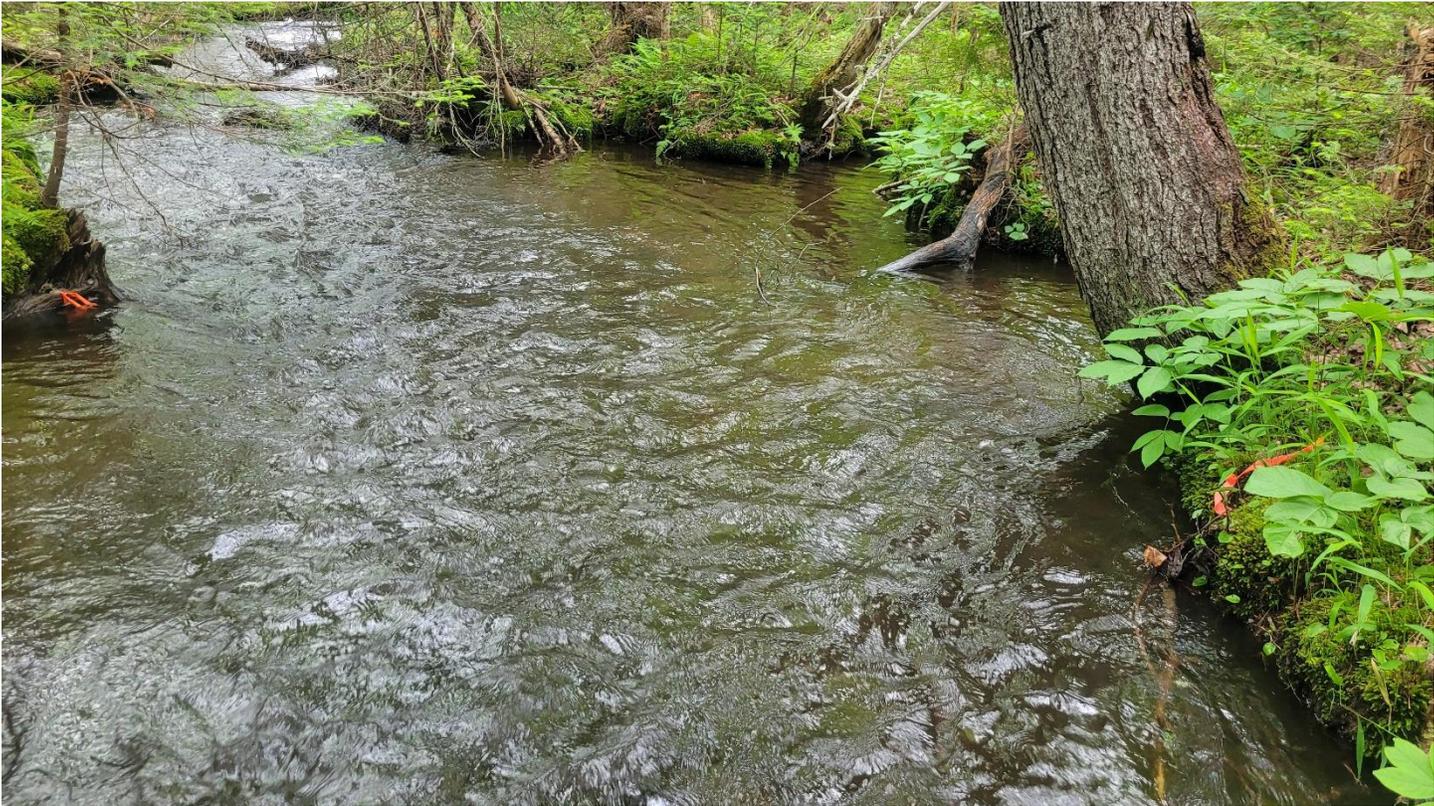
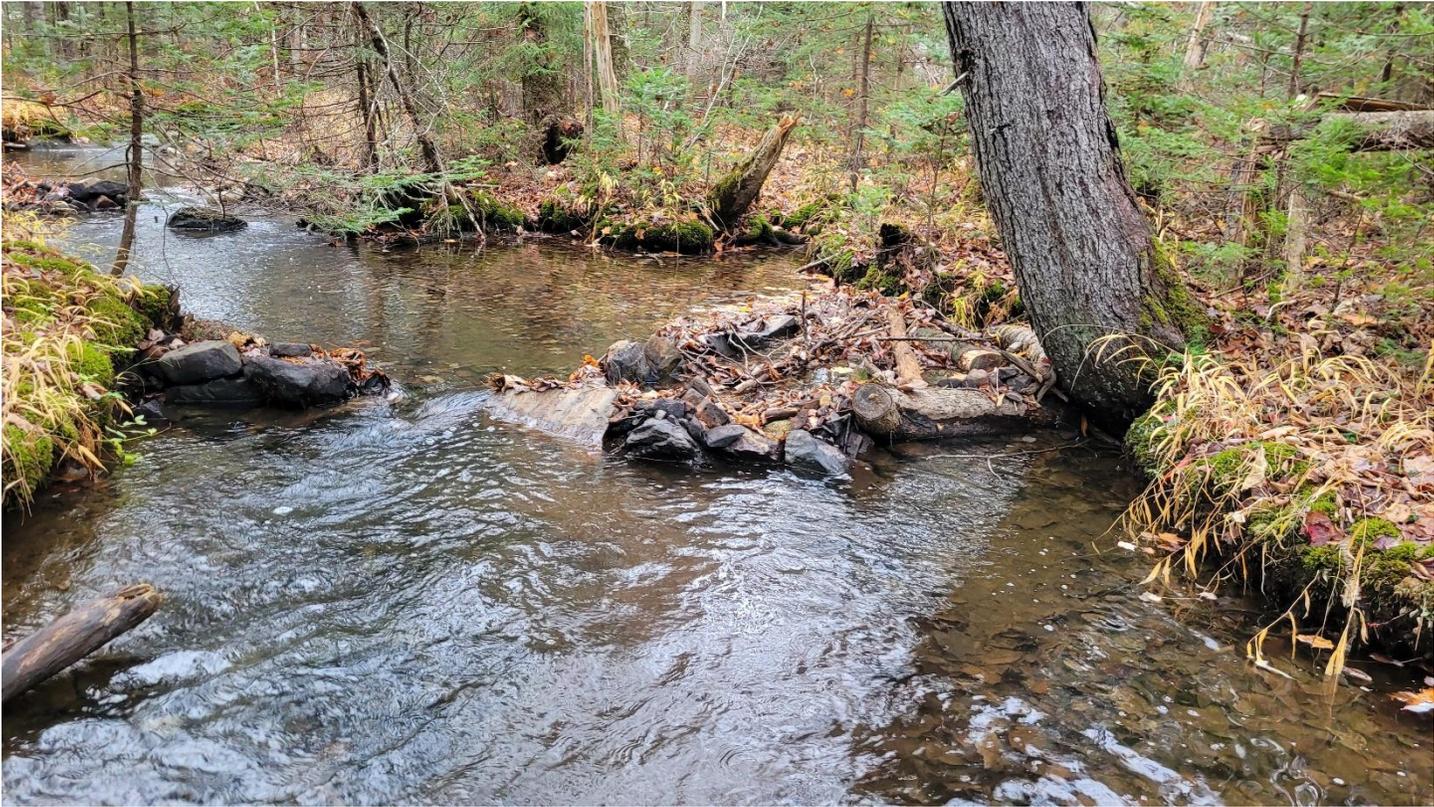
Site 5 – Rocksill with deflector - before (above) and after (below)

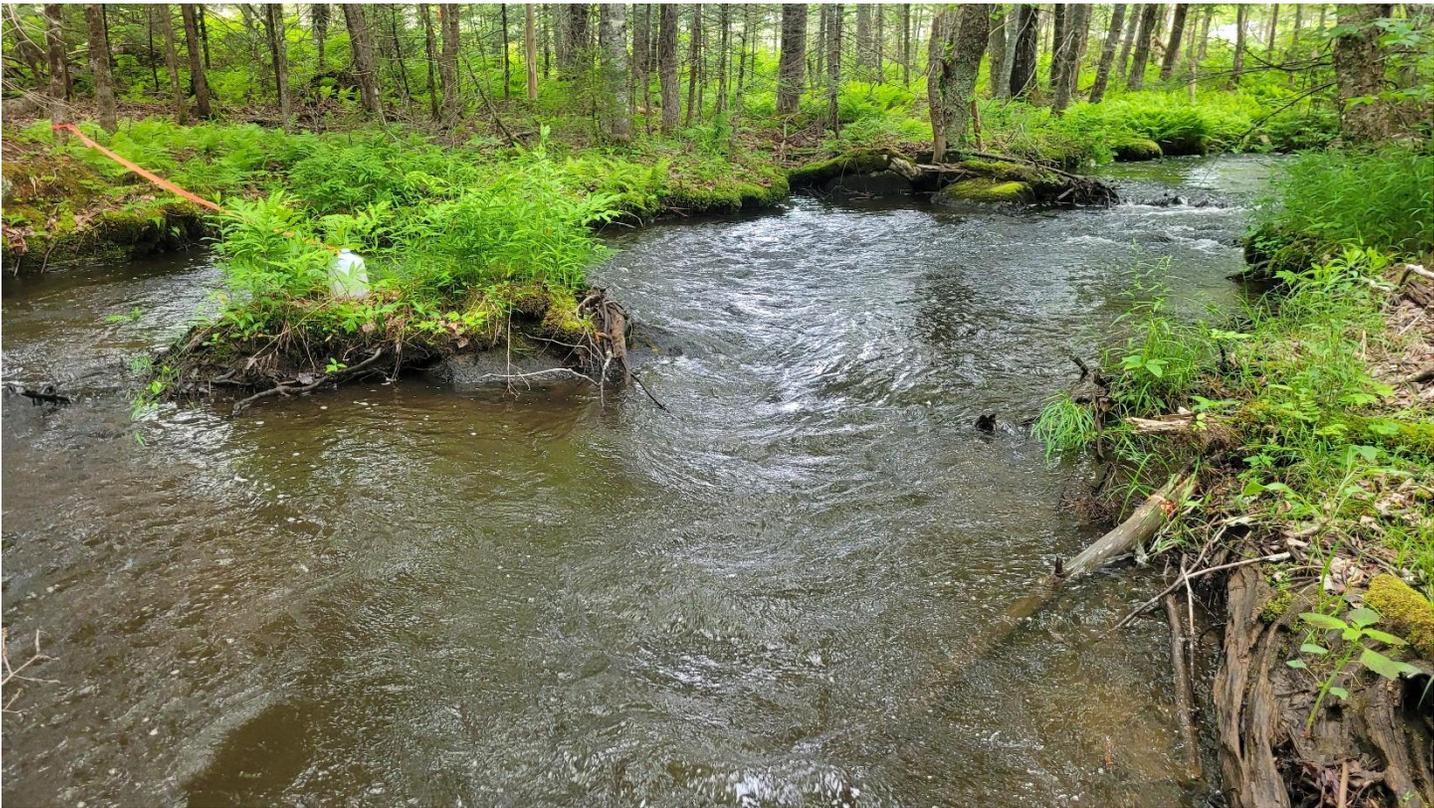
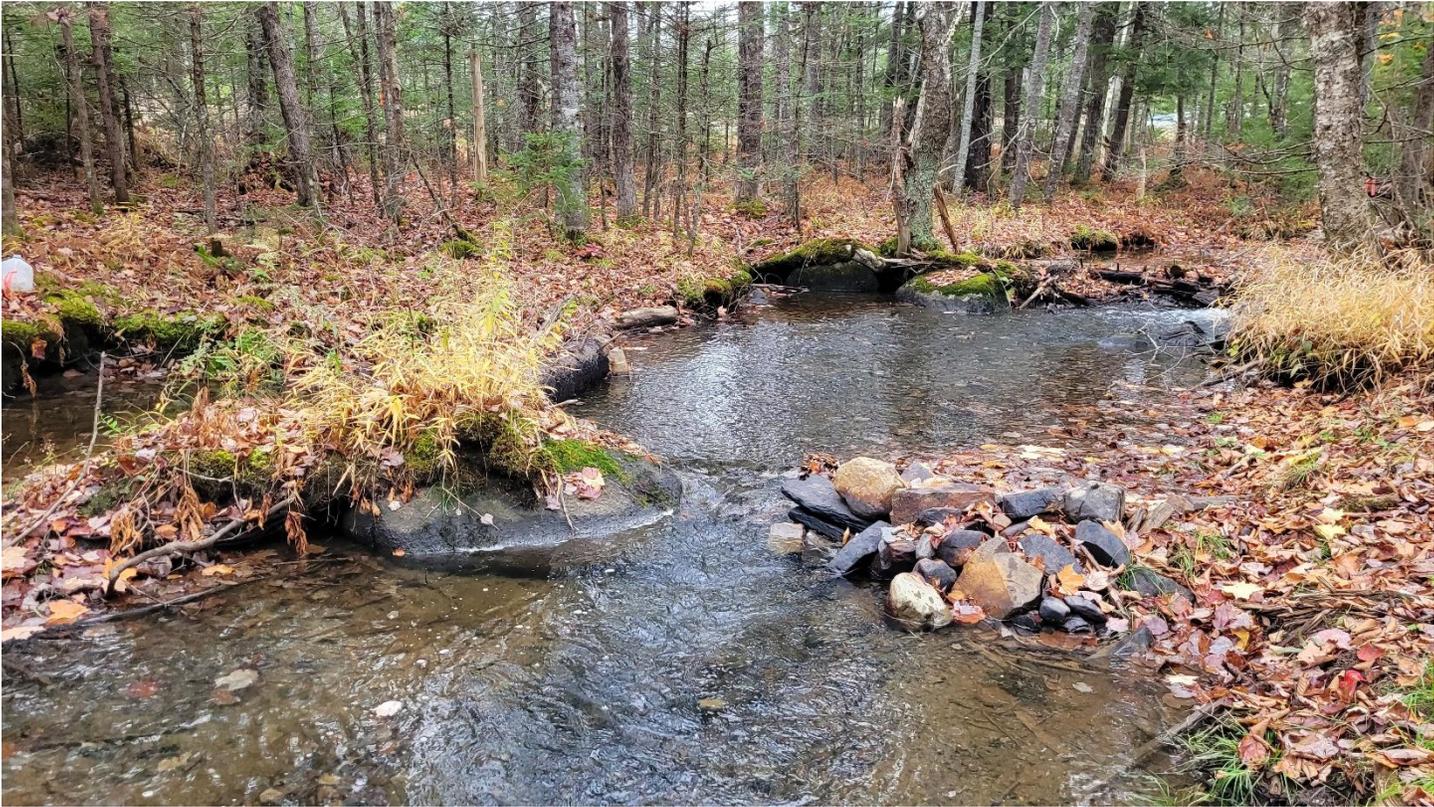
Site 7 – Rocksill with deflector and channel block (left) - before (above) and after (below)

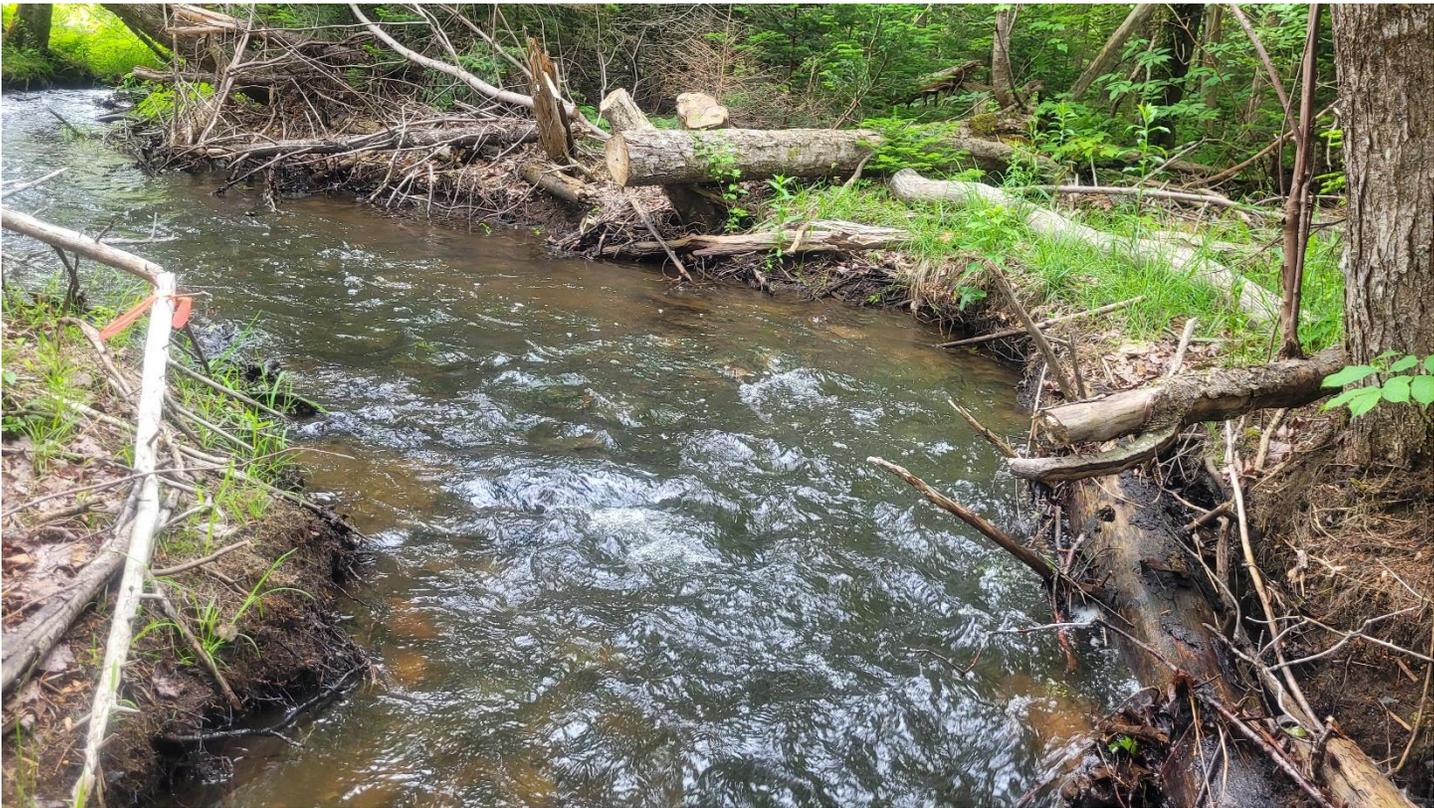
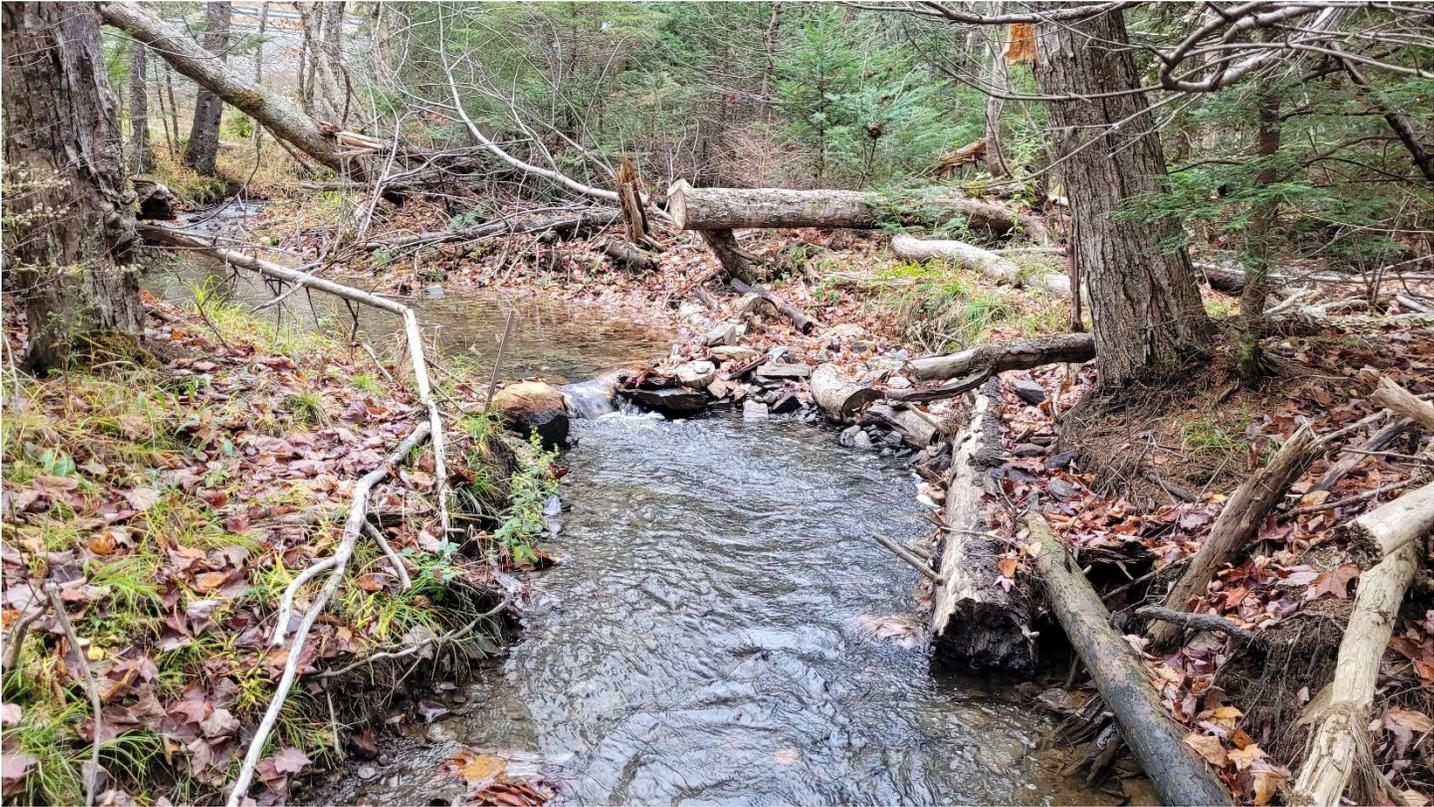
Site 10 – Rocksill with deflector - before (above) and after (below)

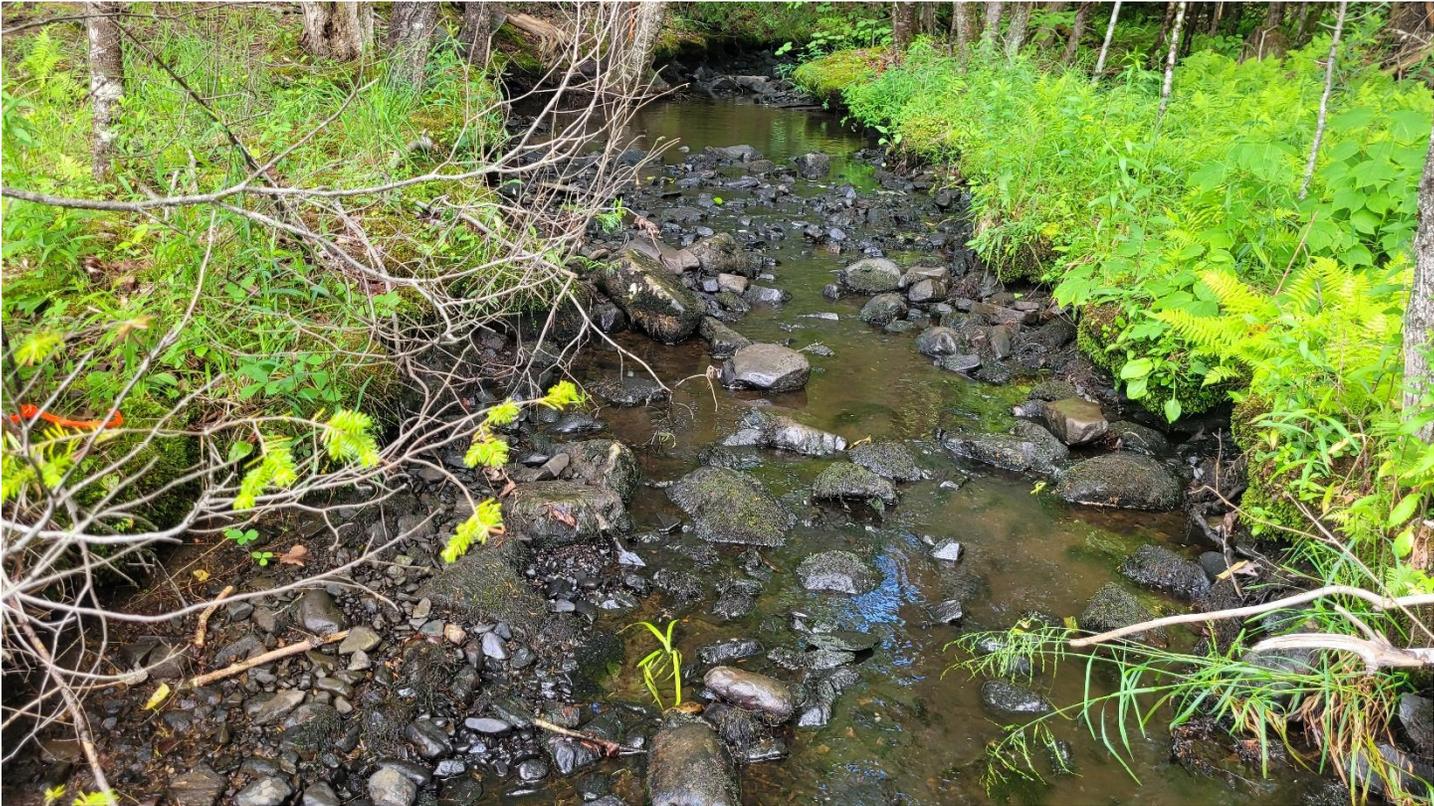
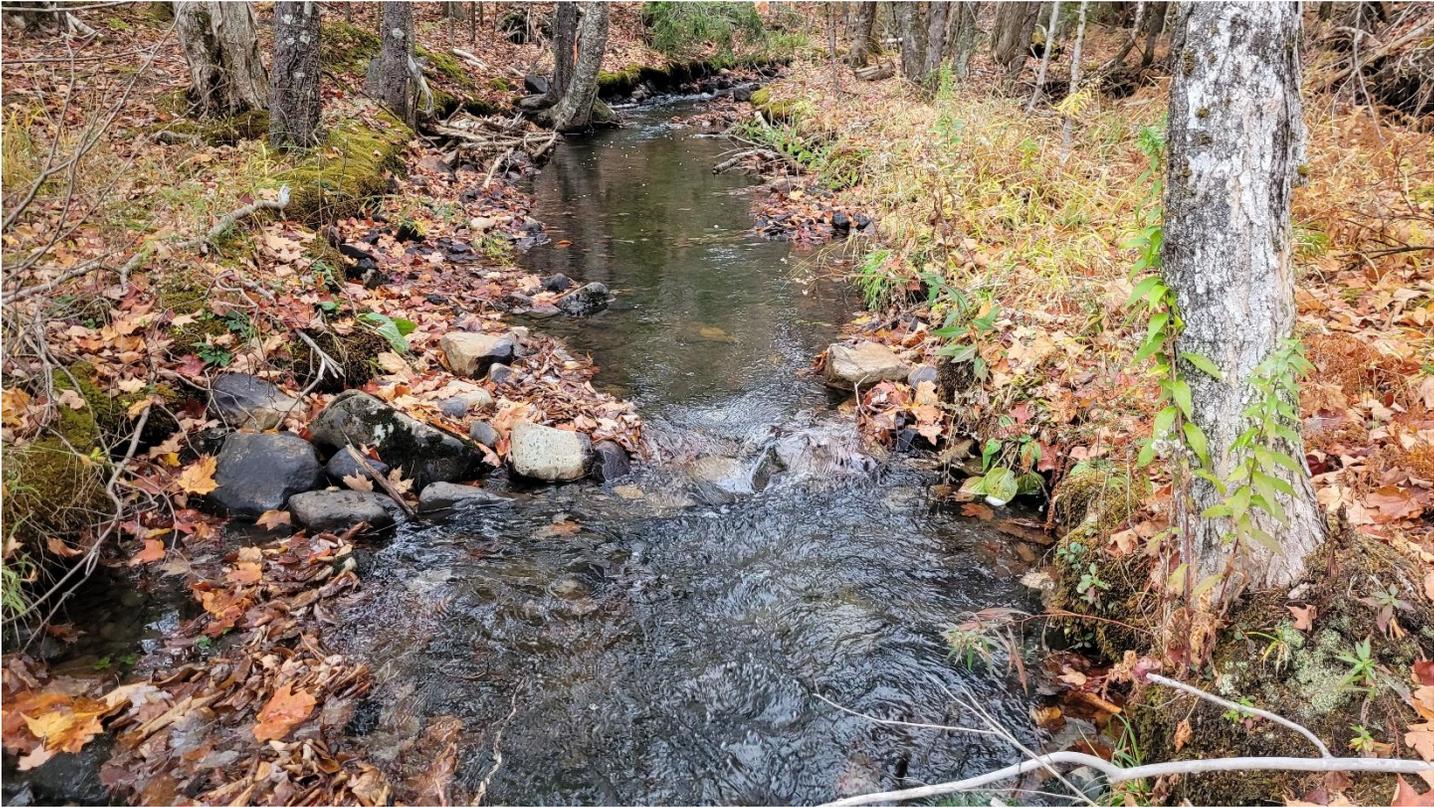
Site 13 – Rocksill with deflector - before (above) and after (below)

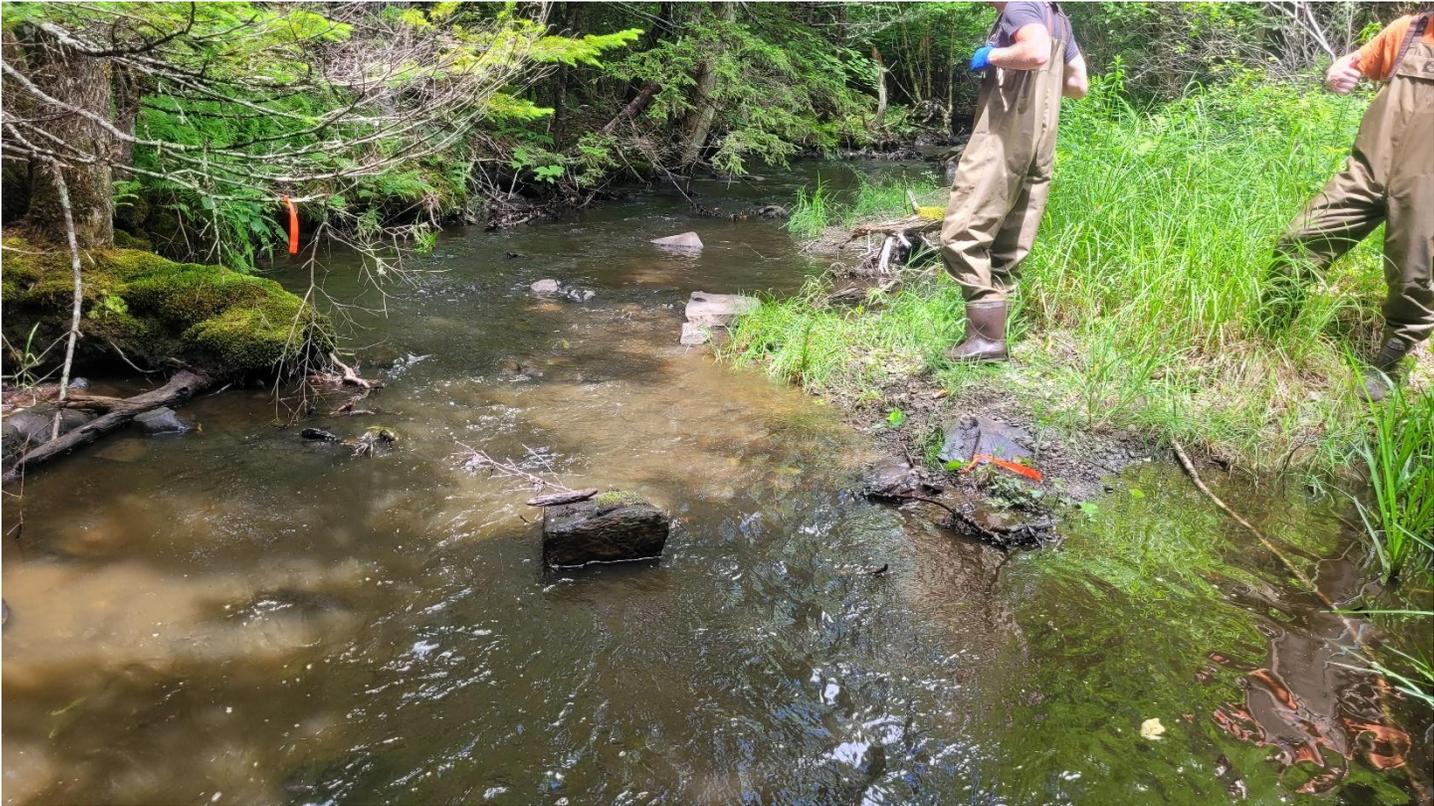
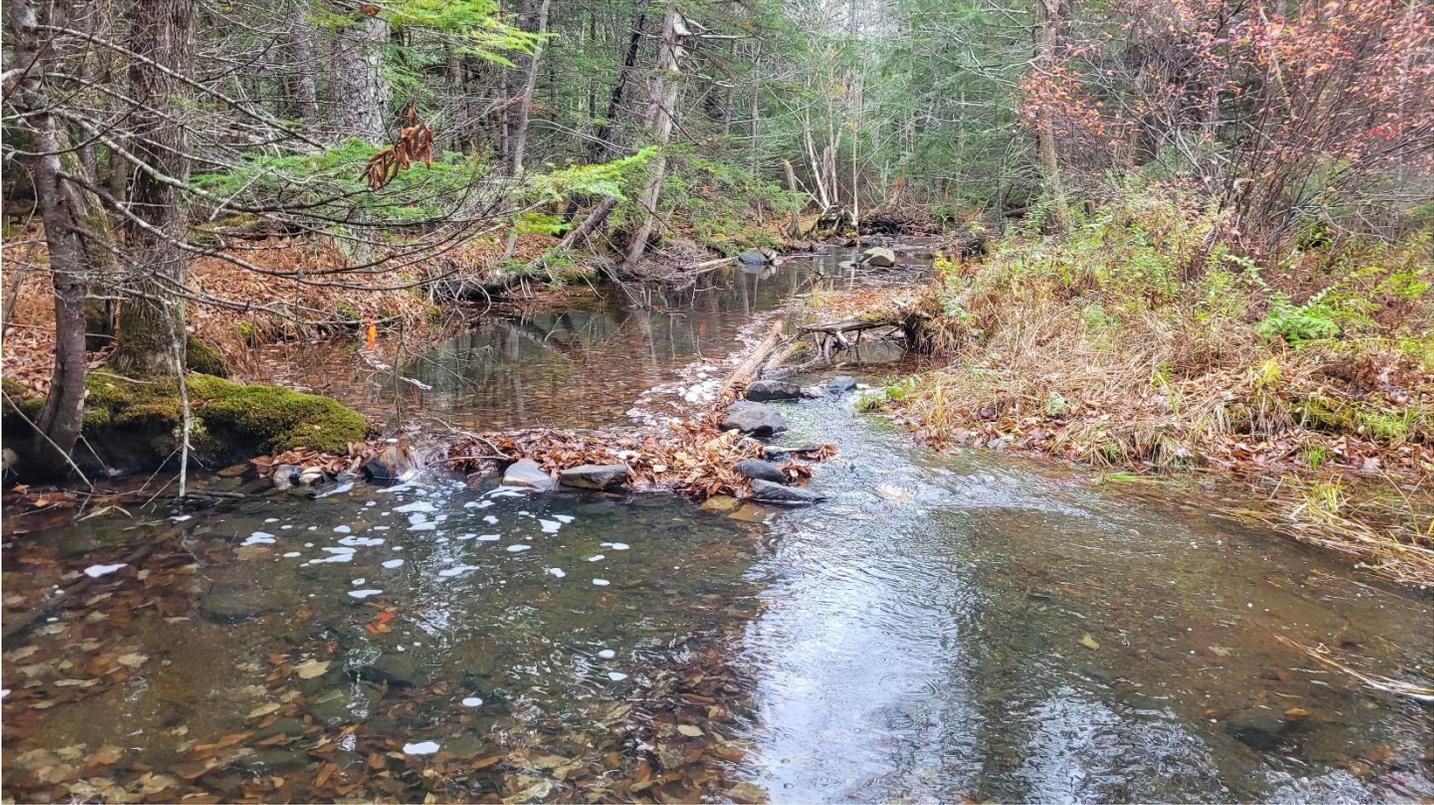
Site 29 – Rock sill with deflector - before (above) and after (below)

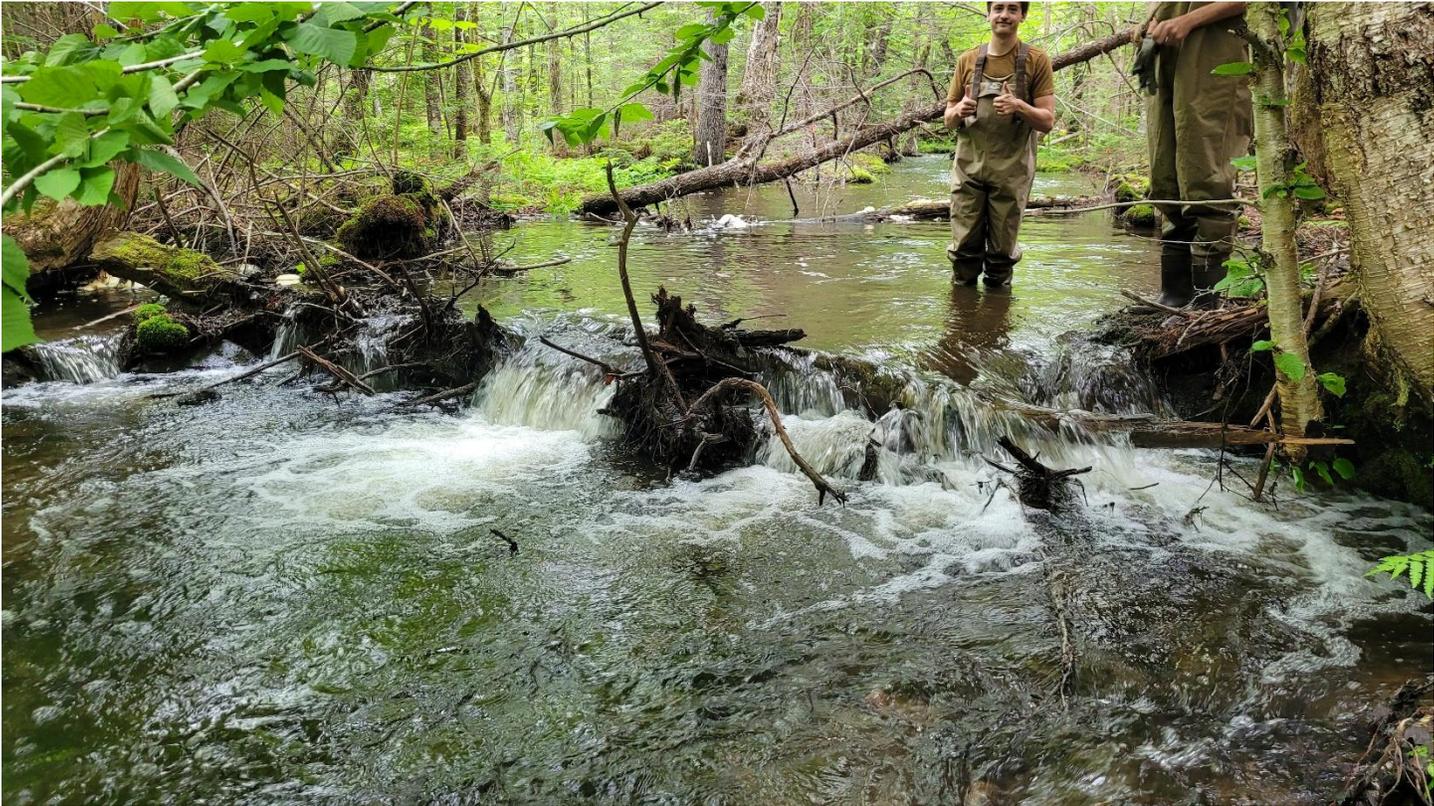
Debris jam prior to clearing on Drain Lake Brook
